# REPUBLIC OF SERBIA CENTER FOR INVESTIGATION OFACCIDENTS IN TRANSPORT SECTOR FOR INVESTIGATION OF ACCIDENTS IN RAILWAY TRAFFIC Belgrade

Date: 26.09.2025.

# ANNUAL REPORT FOR 2024

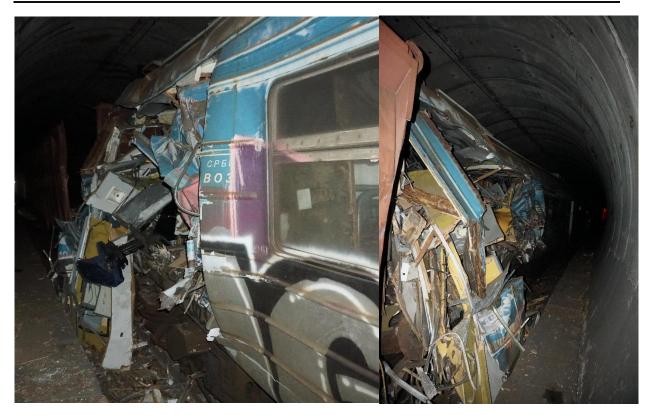
**Figure 3.1.1:** Appearance of the damage on the front part of the motor coach 412-005 of the train No. 7112 after the accident

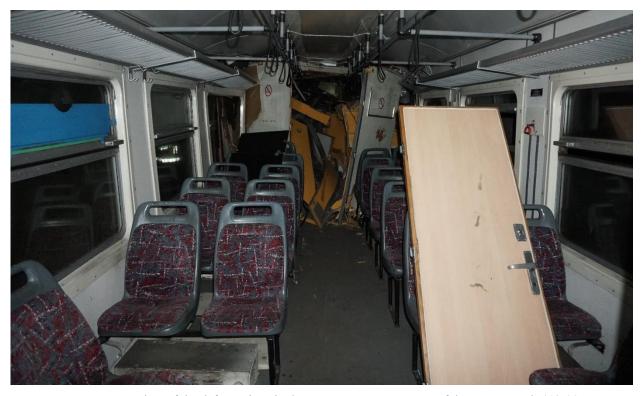
**Figure 3.1.2:** View of the deformations in the passenger compartment of the motor coach 412-005 of the train No. 7112 after the accident

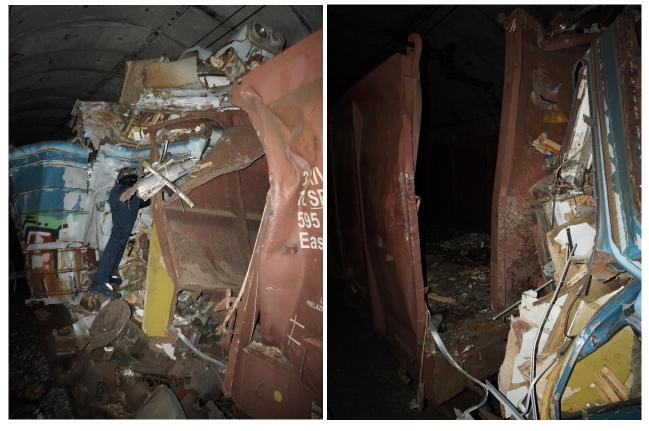
**Figure 3.1.3:** Appearance of the deformation of the wagon No. 31 72 5959 453-7 in the train No. 52601 after the accident

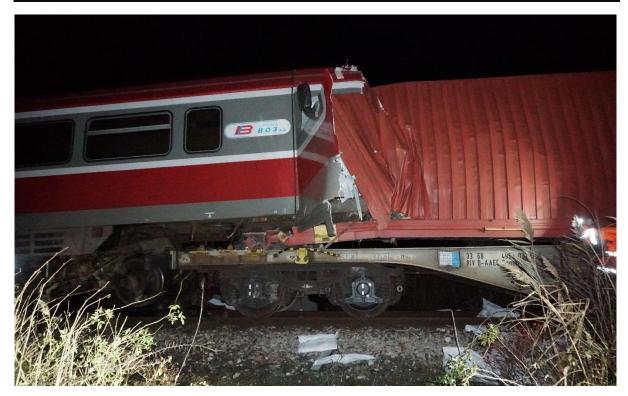
The collision occurred when the front of train No. 25412 (the front part of DMV 711-078), which was moving, struck the end of train No. 49028/73478 (into the last wagon No. 33 68 4952 037-2), which was stationary due to a locomotive 753-782 failure.

Figure 4.1.1.1: The appearance of the train collision

The direct cause of the serious accident is that two trains were at the same time at one distance between the stations, where one train was stationary (train No. 49028/73478), while the other train was moving (train No. 25412), which is contrary to the provision of paragraph 3 of Article 122 of the Traffic Rulebook ("Official Gazette of RS" No. 34/22 and 107/22). The train dispatcher of the Ratkovo station dispatched train No. 25412 in the direction of the Odžaci station without the previously requested permission for the train No. 25412 from the train dispatcher of the Odžaci station, which is contrary to paragraphs 1 and 2 of Article 121 and paragraph 1 of Article 133 of the Traffic Rulebook ("Official Gazette of RS" Nos. 34/22 and 107/22).

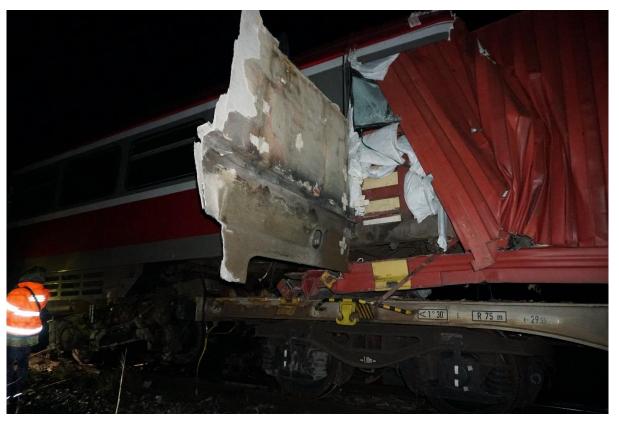
**Figure 4.1.1.2:** The appearance of the damages on the front box part of DMV 711-078 and on the container *CNEU* 453486-3

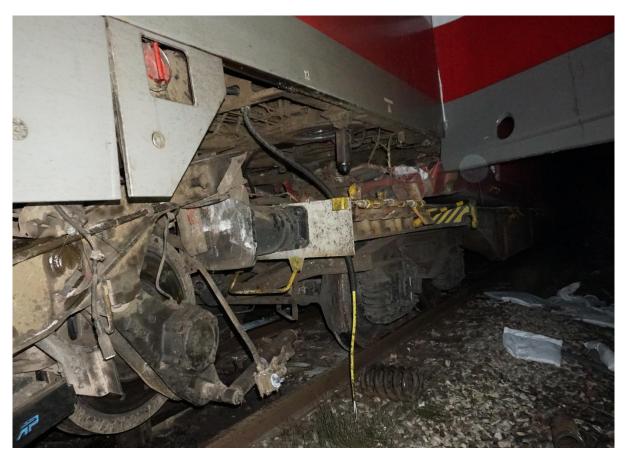
Figure 4.1.1.3: The appearance of the damages on the wagon No.33 68 4952 037-2

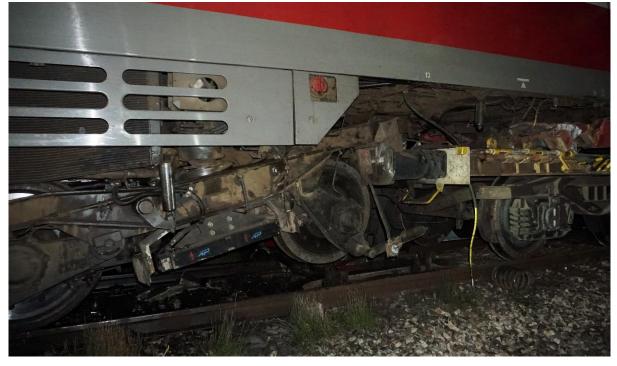
Figure 4.1.1.4: The appearance of the shifted bogie on DMV 711-078

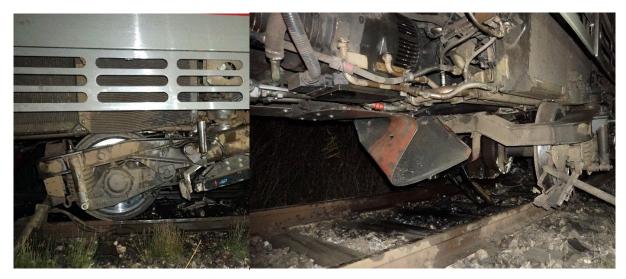
Figure 4.1.1.5: Appearance of damages on the power unit DMV 711-078
