FINAL REPORT

PIPER PA 28RT-201T

YU-DZZ

UNCONTROLLED LANDING GEAR RETRACTMENT

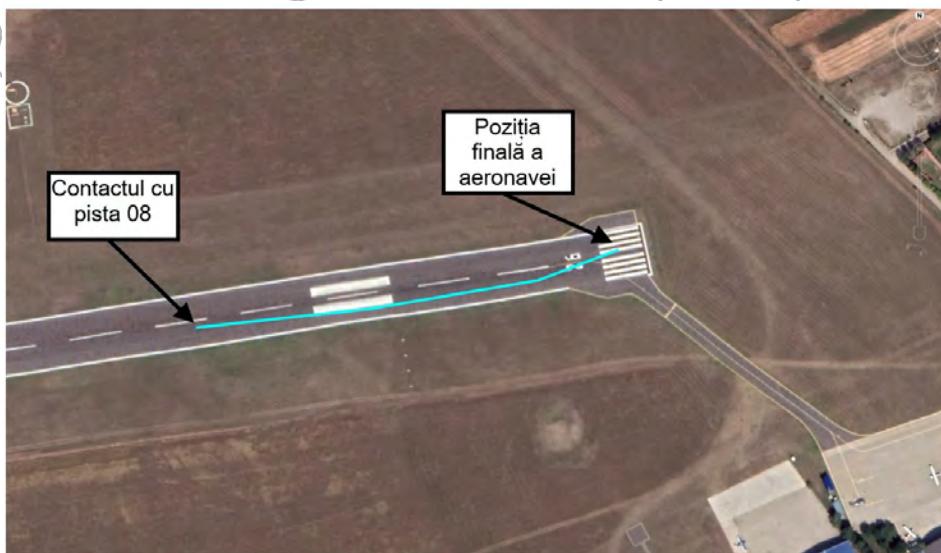
Figure 1 - Aircraft trajectory after contact with the runway

After touching down, the landing gear began to retract slightly until the aircraft's fuselage made direct contact with the runway surface. From the moment the

fuselage touched down, the aircraft traveled approximately 250 m before coming to rest at the end of the runway.

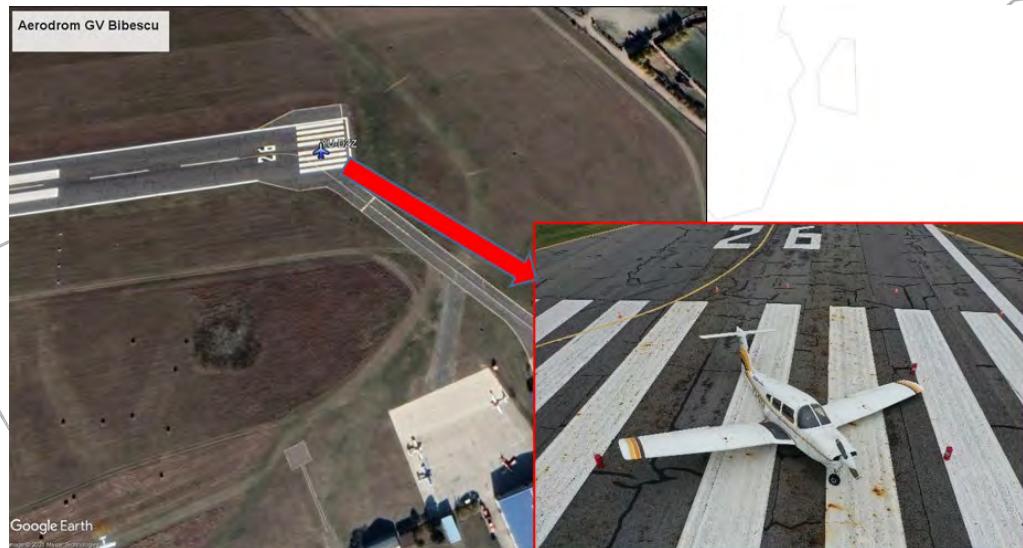
Figure 2 - Final position of the aircraft

Although he received visual confirmation from the flight coordinator that the landing gear was extended, during the taxi after landing the main landing gear retracted without command.

In the first part of the taxi after contact with the ground, the weight of the aircraft was taken over by the sides of the two wheels of the main landing gear and the front landing gear and only in the last part, at low speed, by the ventral side of the fuselage. Due to the contact between the fuselage and the runway at a relatively low speed, the aircraft did not suffer any important damage.

When checking the aircraft in order to determine the cause that led to the occurrence of the event, a failure was found in the electrical control circuit of the landing gear, which caused the uncontrolled unlocking of the landing gear in the extended position. The failure of the electrical control circuit of the landing gear was confirmed by the impossibility of re-locking its safely.

Immediately after the incident, the defect in the electrical circuit was repaired and the aircraft resumed its aerial work missions.

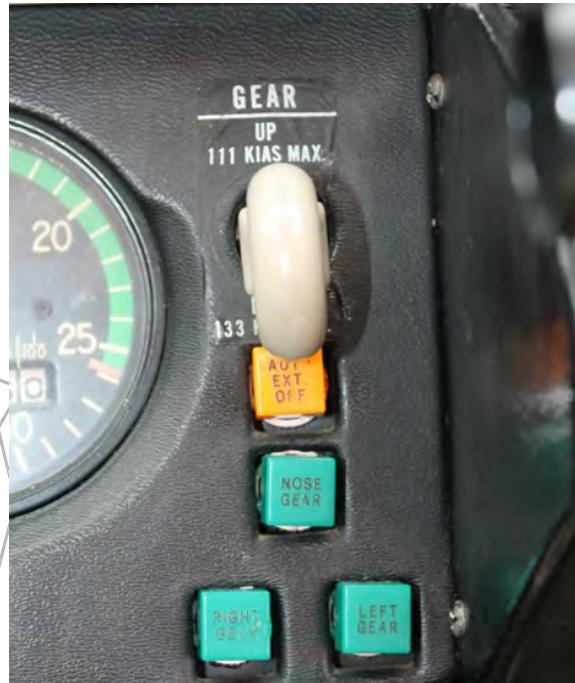
Figure 3 - Landing gear control selector

The aircraft is equipped with a retractable tricycle landing gear, hydraulically actuated by an electric reversible pump. The pump is controlled by a selector on the instrument panel.
