REPUBLIC OF SERBIA
CENTER FOR INVESTIGATION OF ACCIDENTS IN TRANSPORT
SECTOR FOR INVESTIGATION OF ACCIDENTS IN WATERBORNE TRAFFIC
Nemanjina 11, 11000 Belgrade

No.: 342-00-5/2025-03-9

Date: 29.12.2025

ANNUAL REPORT FOR 2024

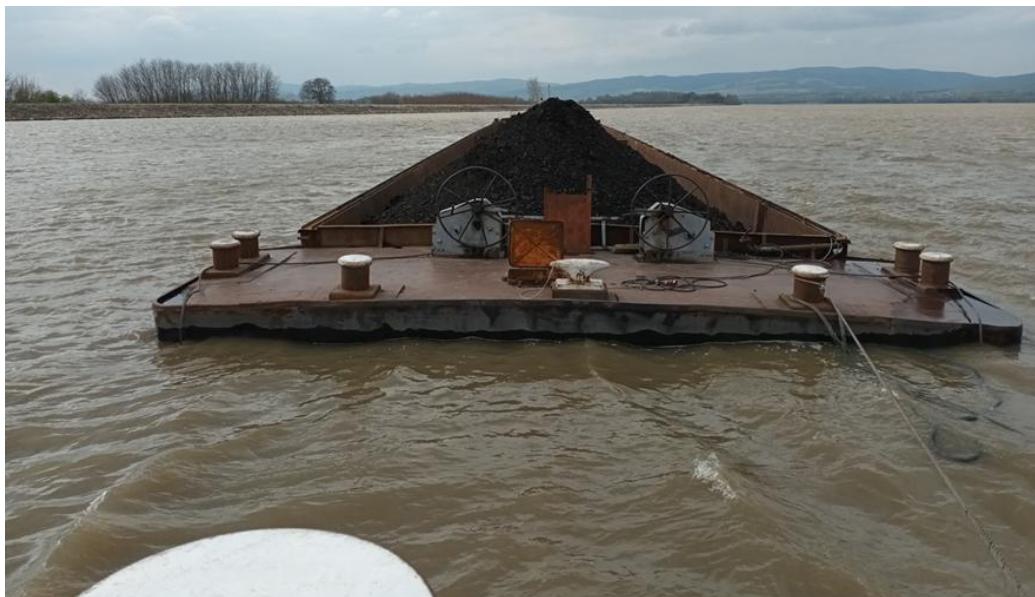
Figure 4.1.1.4.

was continuously taking on water and had developed a transverse list to the starboard side (Figure 4.1.1.4).

Due to the ingress of water into the internal compartments, the pusher initially developed a stern trim and a loss of reserve buoyancy in that part of the hull. This was followed by deck flooding and the overflow of external water over the coaming into the cargo space. Based on the commander's report, it can be observed that the pusher was continuously taking on water inside the hull, which during the given time period resulted in the flooding of both cargo compartments and its sinking on 08 April 2023 at approximately 05:30 (Figure 4.1.1.5).

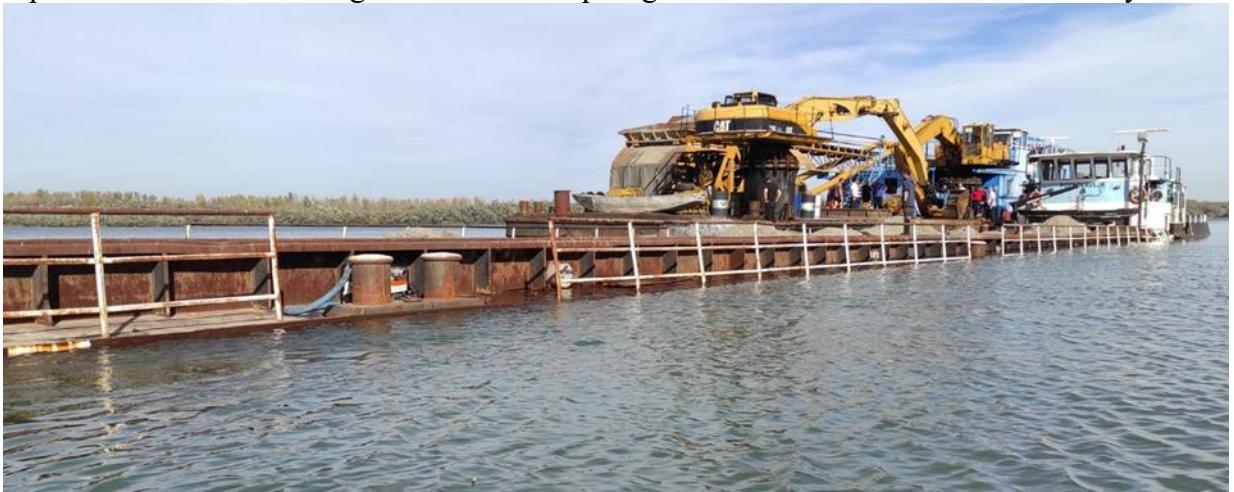
On October 30, 2023, at approximately 05:00, at river kilometer 1106 + 200 m along the right bank of the Danube River, a navigation incident occurred involving the partial sinking of the anchored motor cargo vessel "PODUNAVLJE" (see Figure 3.3.1). The vessel flies the flag of the Republic of Serbia and is registered in the Ship Register of the Smederevo Port Authority.

Figure 4.2.1.1. Motor cargo vessel "PODUNAVLJE" at km 1106 + 200 m of the Danube river

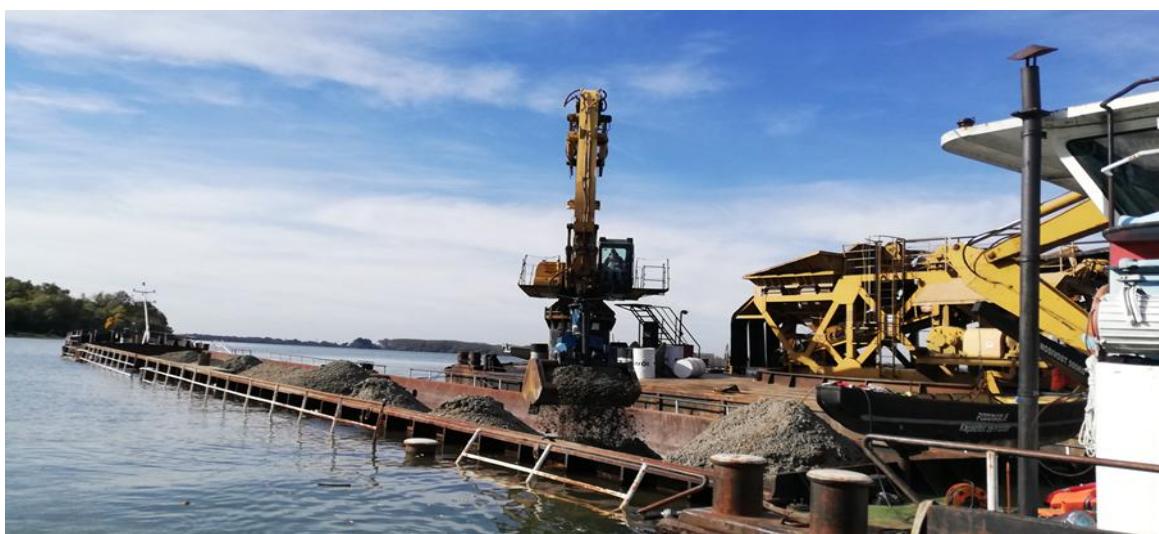
Figure 4.2.1.3.

After the vessel had anchored, an inspection of the draft marks showed, according to the shipmaster's Statement, that the draft was unchanged at 205 cm. During the morning of 29 October 2023, at 05:00, the Master observed an increased draft of the vessel, i.e. that water had flooded the main deck on the port side toward the stern, meaning that the freeboard was $Fr = 0$ cm. The Master immediately started the main propulsion engine in order to intentionally ground the vessel as close as possible to the right bank (shallow water area) and dropped the bow anchor. In an effort to save the vessel, the crew engaged two electric pumps and two engine-driven pumps to remove water from the cargo hold and side compartments. The Port Authority of Smederevo was informed of the emergency situation and the vessel's position. Through the subsequent engagement of salvage pumps and the arrival of unloading equipment (a technical floating facility – elevator) "RAVANGRAD", as well as by lightening the vessel's cargo space, the loss of conditional seaworthiness and the sinking of the vessel were prevented (Figure 4.2.1.3).

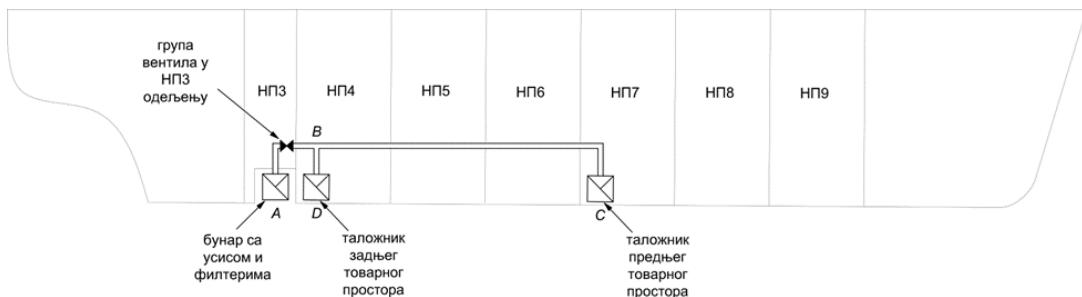
The flooding most likely occurred through the bilge wells in the compartment – watertight space (WT3), via open valves, and further through the piping system to the settling tanks in the compartments – watertight spaces (WT4 and WT7). A simplified schematic of this section of the piping system is shown in Figure 4.2.1.7. The figure shows four positions that will be used in the following analysis: bilge well A, branch B, settling tank C, and settling tank D.

Figure 4.2.1.7. Schematic of the piping system through which the vessel flooding occurred

Based on the analysis of the inland navigation incident in question, the flooding of the cargo vessel "PODUNAVLJE" was, according to all indications, caused by the opening of valves connecting the external water intake from the sea chest in the watertight compartment NP3 with the bilge wells of the cargo spaces in the watertight compartments NP4 and NP7. From that moment, water flowed by gravity (free flow, without the operation of pumps) toward the bilge wells in the forward and aft cargo holds, thereby flooding the vessel.

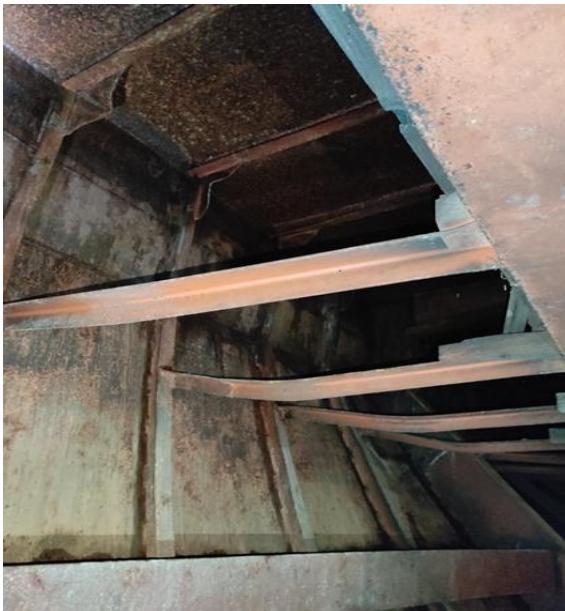
Figure 4.2.1.19.

3. Ship structure: During operation, the ship's structure, due to the action of stress forces on structural elements (longitudinal and transverse framework) and the hull plating, has caused permanent plastic deformations (according to the technical supervision report, a hull bend was observed). The cargo hold in the interframe sections, with transverse stiffening, is plastically deformed (Figure 4.2.1.19), and the condition of the outer plating is no better.

SR_01/24 It is recommended that the owner/operator address the following identified deficiencies:

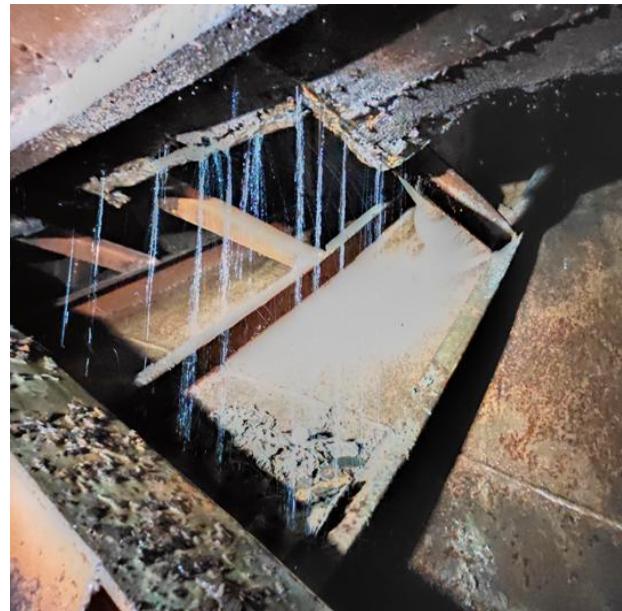
Figure 4.2.1.20.

In the cargo hold, at the junctions of sloped parts, visible leakage is present (Figure 4.2.1.20). The double bottom shows localized porosity in the plating. Structural deformation is observed in watertight compartment NP2 on the starboard side, extending from the end of the accommodation space toward the side. Arbitrarily executed, averaged, and unsealed passages exist through bulkheads for electrical conductors. Cutting of frames for pipeline passages, as well as watertight bulkheads, is evident. Pipe passages through bulkheads are made without using watertight penetrations. Deck hatches leading to the wing tanks are not watertight. In the first port-side wing tank, on the tank top, from the bilge toward the middle, there is a grease ball repaired with a box.

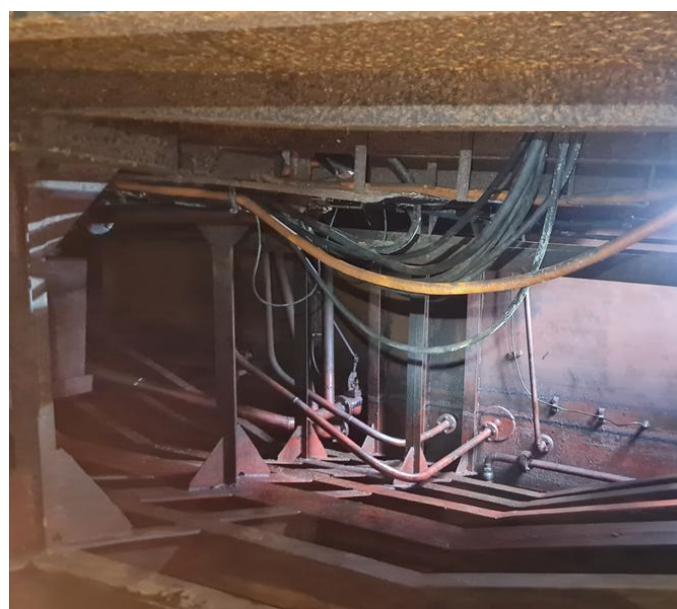
Figure 4.2.1.21.

Electrical installation: On the vessel, there are routes of electrical conductors hanging outside of their conduits; use of extension cords with multiple sockets in the engine room; arbitrary drilling of watertight bulkheads for the passage of power cables (Figure 4.2.1.21) without the use of proper high-temperature-resistant sealing compounds; a cut electrical conductor intended for power supply in watertight compartment NP12; anchor windlass electrical starting is performed via an extension cable along the deck route; electrical connection of the generator to the GRT. The condition of the electrical installation is extremely concerning.
