FINAL REPORT

the investigation of a serious incident that occurred on 26.11.2017 with aircraft ATR 72-202, registration YU-ALO, used by air operator “AIR SERBIA”, during the initial climb after take-off from Sofia Airport

2019

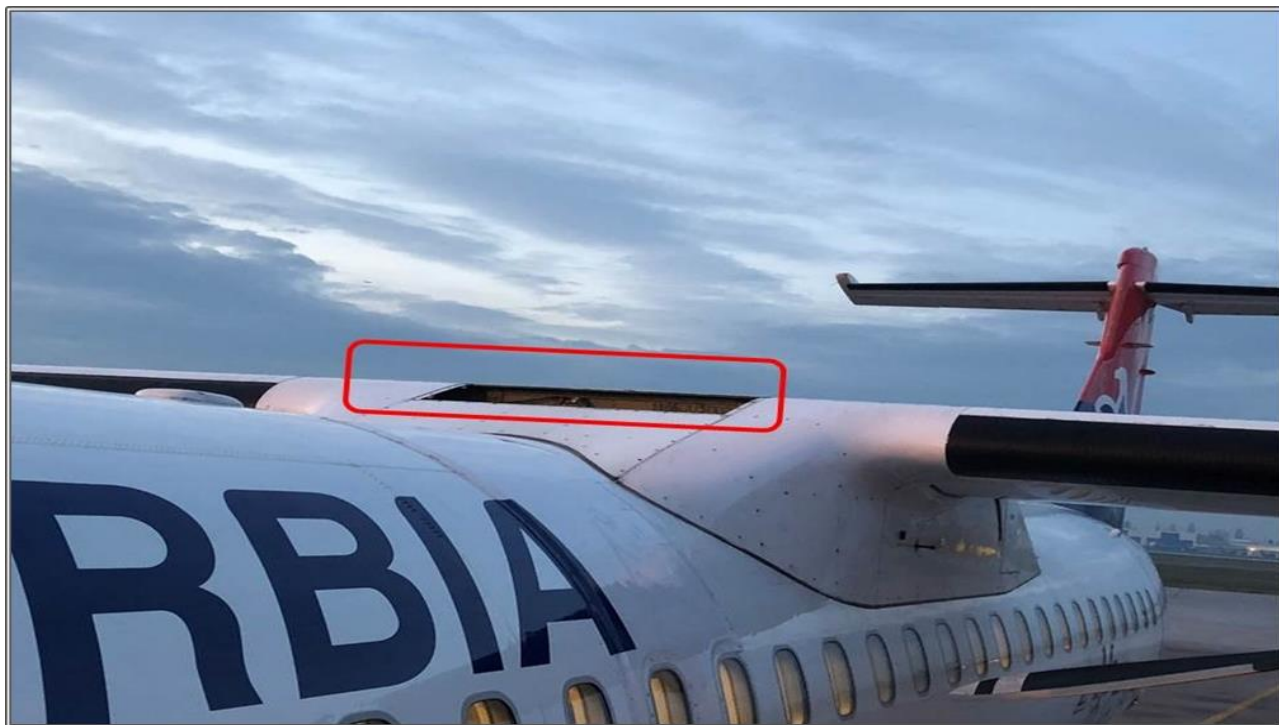
Figure1

vectored back to Sofia Airport. The crew assumed that there was a detached panel or problems with the nose landing gear, without having any indications of that. At about 16:12 h, the crew requested a longer approach since they had doubts regarding the condition of the nose landing gear. The airport emergency services were alerted. The aircraft was guided by vectors to intercept the final approach 15 nm from the runway threshold. At 16:17 h, the crew reported safe landing gear down indication, including the nose landing gear and the aircraft touched down normally on Runway 27 at 16:21. There were no injuries to the passengers and the crew. The aircraft was parked on a parking stand. After an inspection of the plane, conducted at the parking stand, it was found that a panel from the central part of the wing to fuselage fairing was missing. A photo of this section of the plane is shown in figure 1.

During the inspection of the aircraft implemented after the serious incident, no other damages in addition to the missing panel were found (Figure 1).

1. Inspection of aircraft ATR 72-202, registration YU-ALO, serial number 186, during which it was found that a panel (291 BL) from the central part of the wing to fuselage fairing was missing. A photo of this section of the plane was shown in figure 1;

attachment of the missing aerodynamic panel, it was found that there was only one of the nine bolts attaching the panel. The technical servicing department "Aero Technic BG" has a contract with Air Operator "Air Serbia" for the provision of technical assistance. After the replacement of the missing panel of the aircraft with a new one, the following procedures were performed at Sofia Airport:

Considering the fact that there are no structural damages at the points of attachment of the missing panel, we can conclude that it was had been incorrectly mounted. Owing to the fact that there is no evidence of any broken bolts or twisted points of their fixing, we can draw the conclusion that not all the bolts had been tightened and some of them were missing.

BG.SIA-2017/08/01. The manufacturer to issue a Service bulletin and propose to the AOs operating airplane ATP 72-202 to include in the airplane's Technical Servicing Programme the requirement after any activity involving dismantling and assembling of 291 BL panel, to inspect the bolts and the nests used for its fixing, which to be recorded into the worksheets.

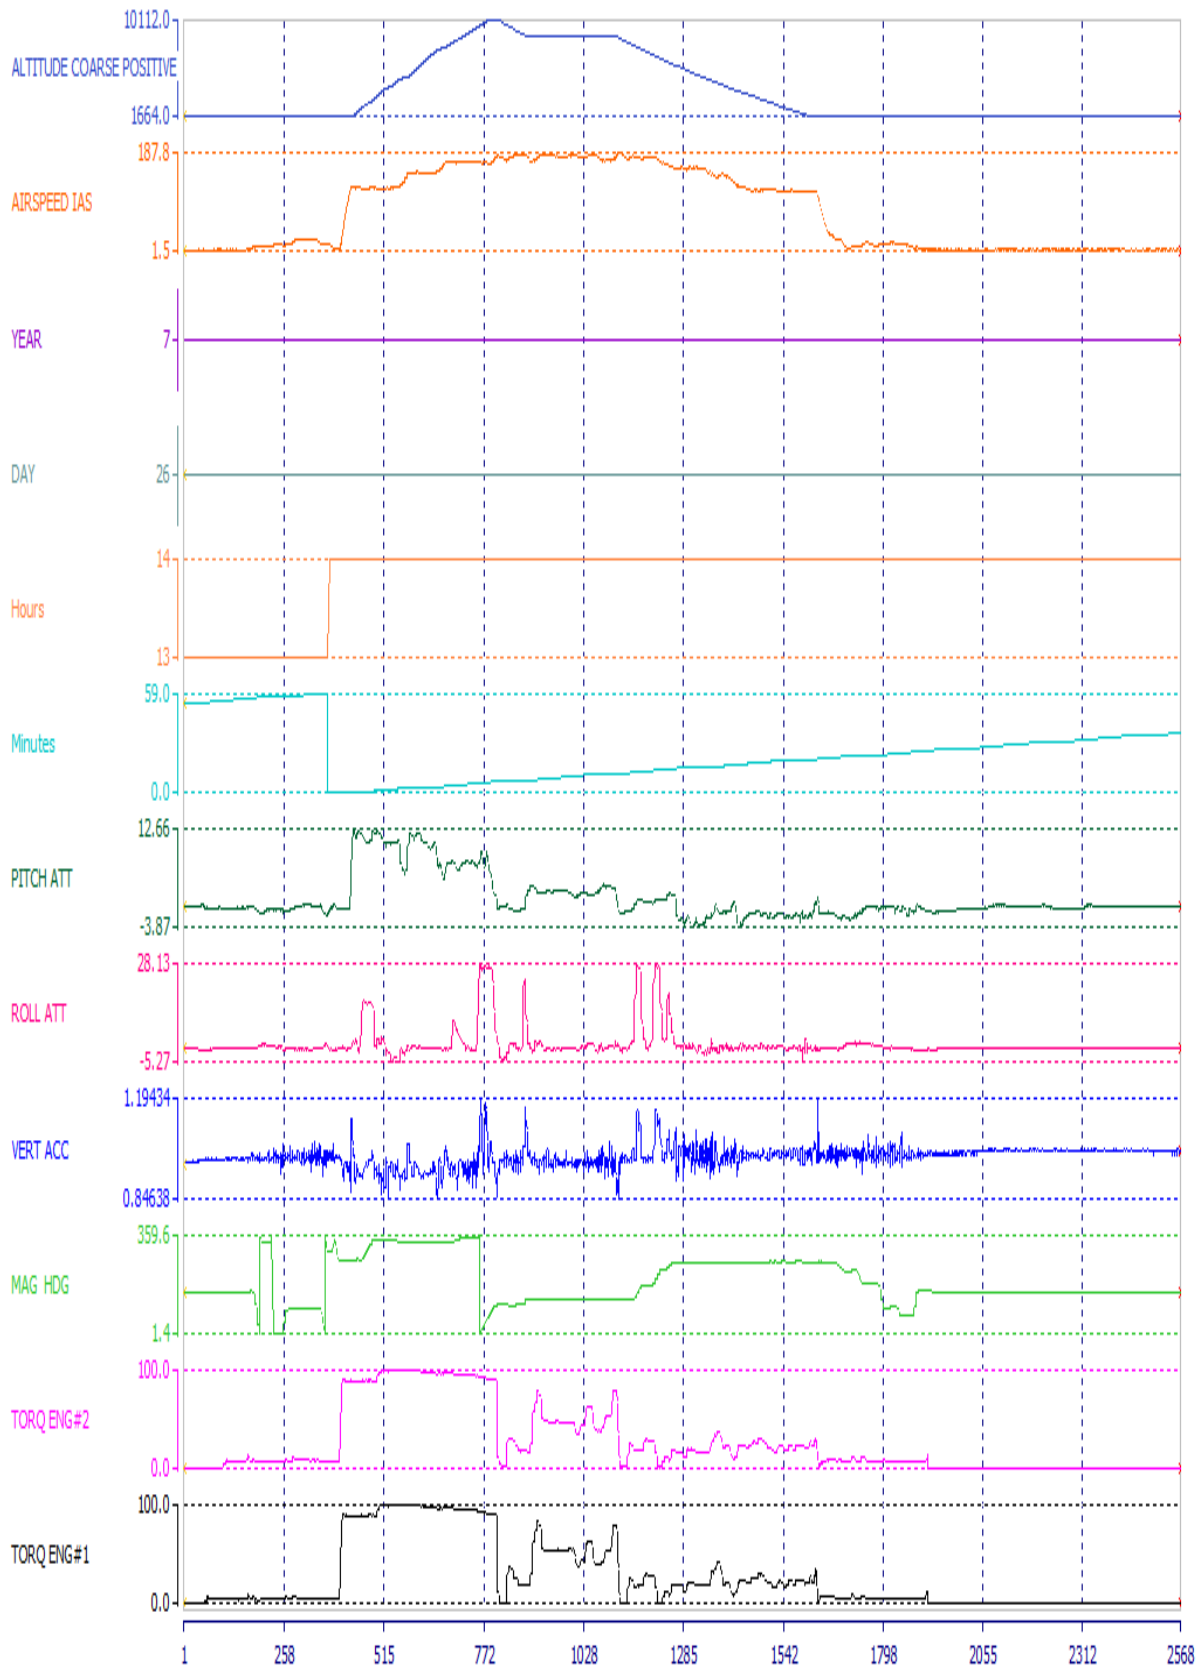
The main parameters of the flight are graphically illustrated in Figure 2 and Figure 3.

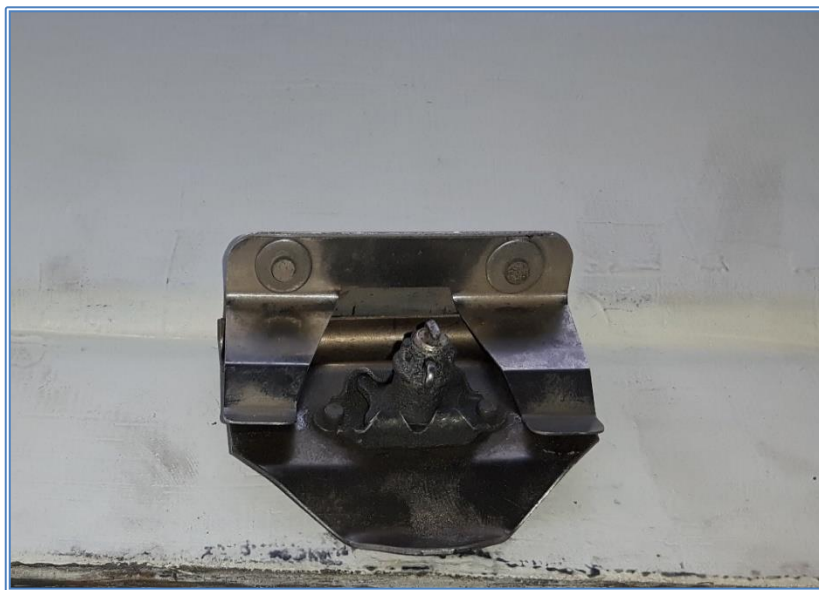
Figure 4

Service bulletin (ATR 72-53-1044) was implemented on aircraft ATR 72-202, registration YU-ALO, serial number 186, in order to replace the hinge nests in which the aforementioned bolts are placed. See figure 4 and figure 5. On the day of the implementation of the service bulletin, the aircraft had flown 3927 hrs 35 min with 4031 cycles.
