ACCIDENT

Aircraft Type and Registration:	Aerospatiale SA341G Gazelle, YU-HMC	
No & Type of Engines:	1 Turbomeca (Safran) Astazou 3A turboshaft engine	
Year of Manufacture:	1974	
Date & Time (UTC):	14 July 2018 at 1540 hrs	
Location:	Private landing field, Enfield, Greater London	
Type of Flight:	Private	
Persons on Board:	Crew - 1	Passengers - None
Injuries:	Crew - None	Passengers - N/A
Nature of Damage:	Helicopter destroyed by fire	
Commander's Licence:	Private Pilot's Licence (Helicopters)	
Commander's Age:	65 years	
Commander's Flying Experience:	266 hours (of which 266 were on type) Last 90 days - 17 hours Last 28 days - 7 hours	
Information Source:	Aircraft Accident Report Form submitted by the pilot and further enquiries by the AAIB

Synopsis

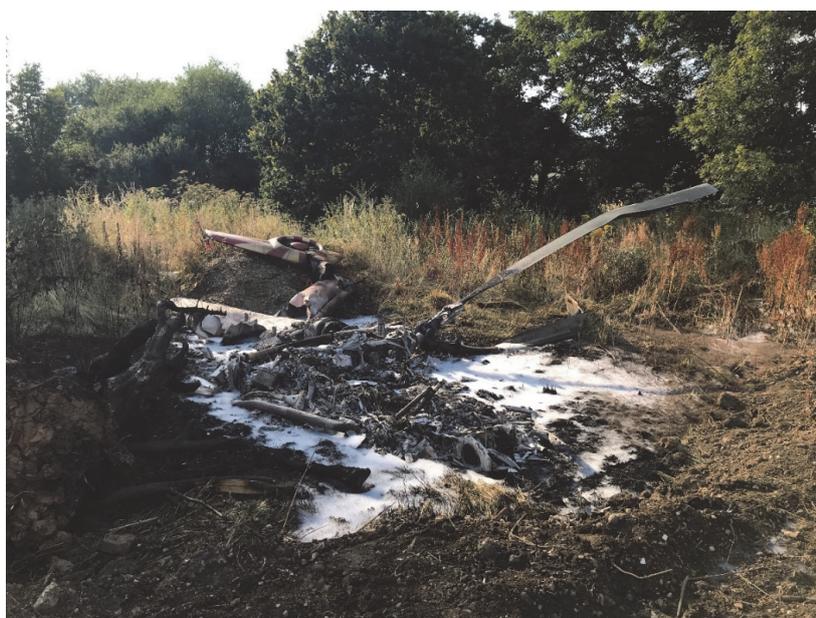
Figure 1

After the fire had subsided, there was very little remaining of the helicopter (Figure 1). The maintenance organisation recovered the helicopter wreckage to their facility and conducted an investigation but were unable to establish a cause of a loss of power. There was no evidence that the engine had suffered an uncontained failure and the turbine was intact and could be rotated through about 30°, but no further due to impact damage to the combustion chamber. There was very little remaining of the fuel system that could be examined. The engineer at the maintenance organisation thought that the fuel tank had probably been punctured by a pallet or metallic materials on the ground where the helicopter came down, resulting in the post-crash fire.

Remains of YU-HMC at the accident site
(image used with permission)
