REPUBLIC OF SERBIA
CENTER FOR INVESTIGATION OF ACCIDENTS IN TRANSPORT
SECTOR FOR INVESTIGATION OF ACCIDENTS IN RAILWAY TRAFFIC
Nemanjina 11, 11000 Belgrade

No.: 340-00-7/2024-02-52

Date: 26.09.2024.

ANNUAL REPORT FOR 2023

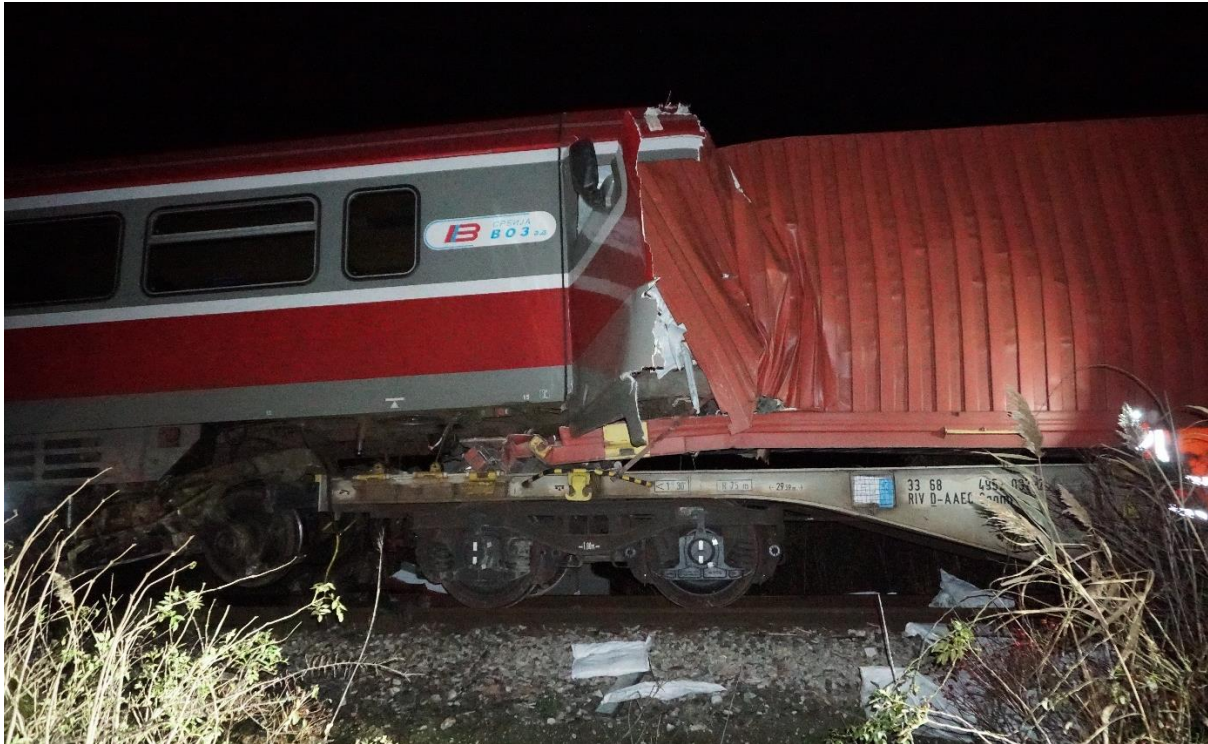
The collision occurred when the front of train No. 25412 (the front part of DMV 711-078), which was moving, struck the end of train No. 49028/73478 (into the last wagon No. 33 68 4952 037-2), which was stationary due to a locomotive 753-782 failure.

Figure 3.1.1: The appearance of the train collision

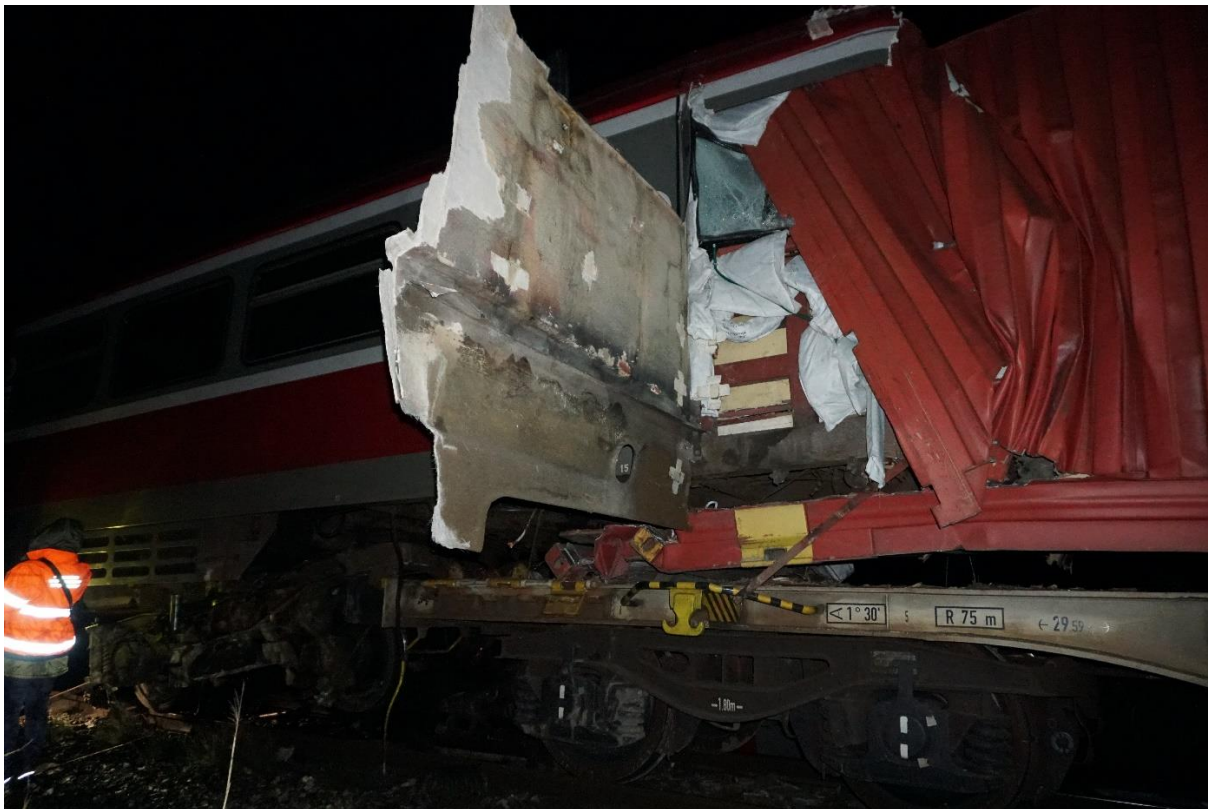
Figure 3.1.2: The appearance of the damages on the front DMV box part 711-078
and on the container CNEU 453486-3

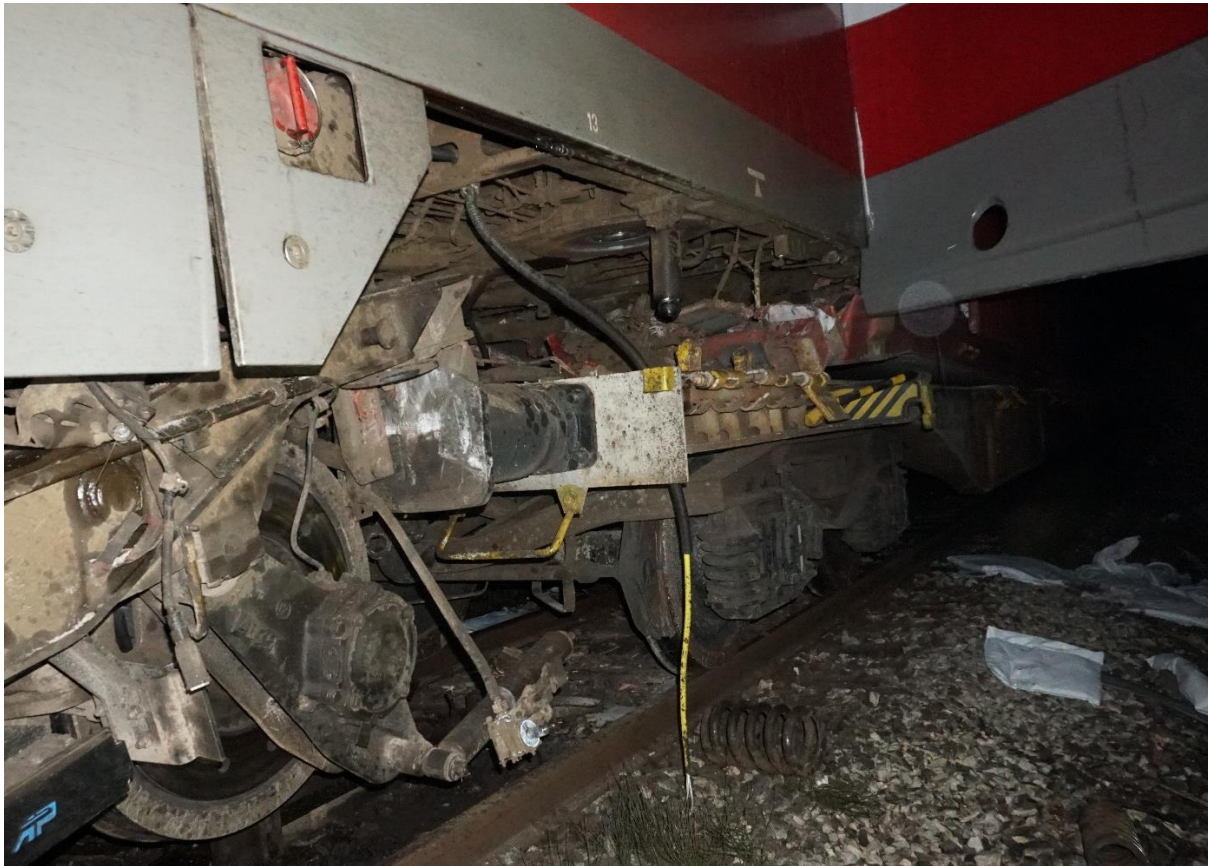
Figure 3.1.3: The appearance of the damages on the wagon No.33 68 4952 037-2

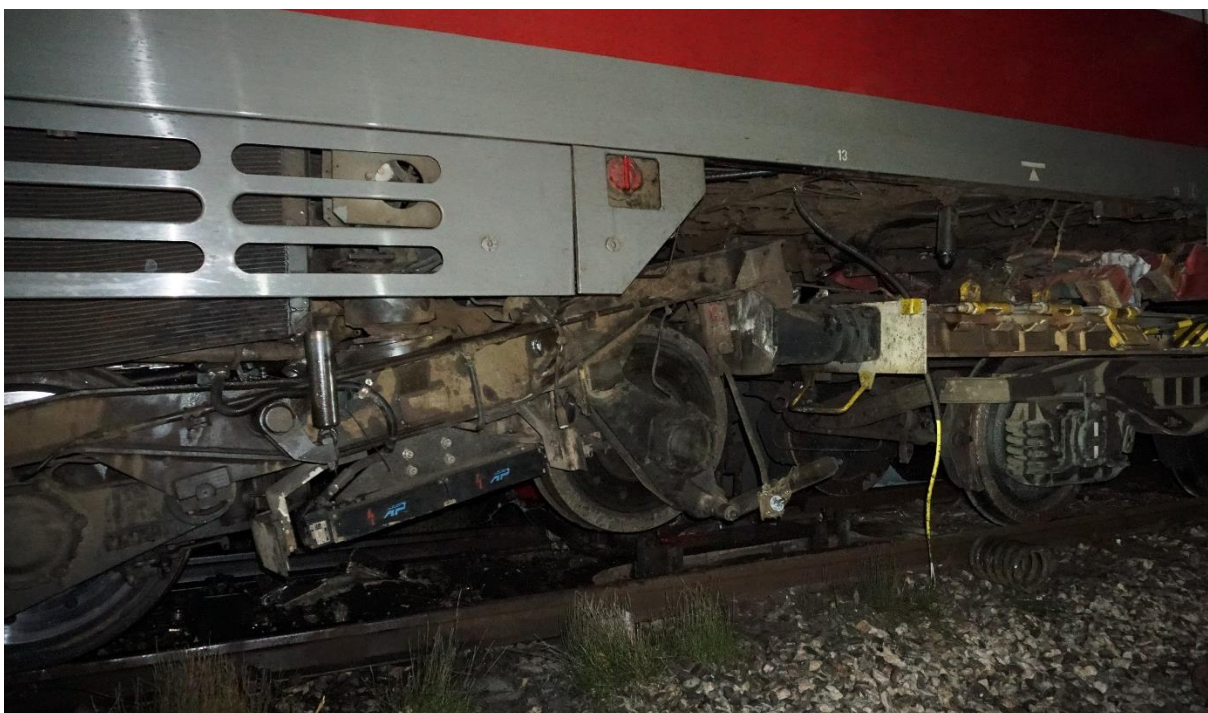
Except for the wheels on the first axle of the first bogie of DMV 711-078 (viewed in the direction of movement), which lifted above the tracks (approximately 30 cm from the top edge of the rail), all other wheels of the vehicles in both trains were on the rails (they did not derail).

Figure 3.1.4: The appearance of the shifted bogie on DMV 711-078

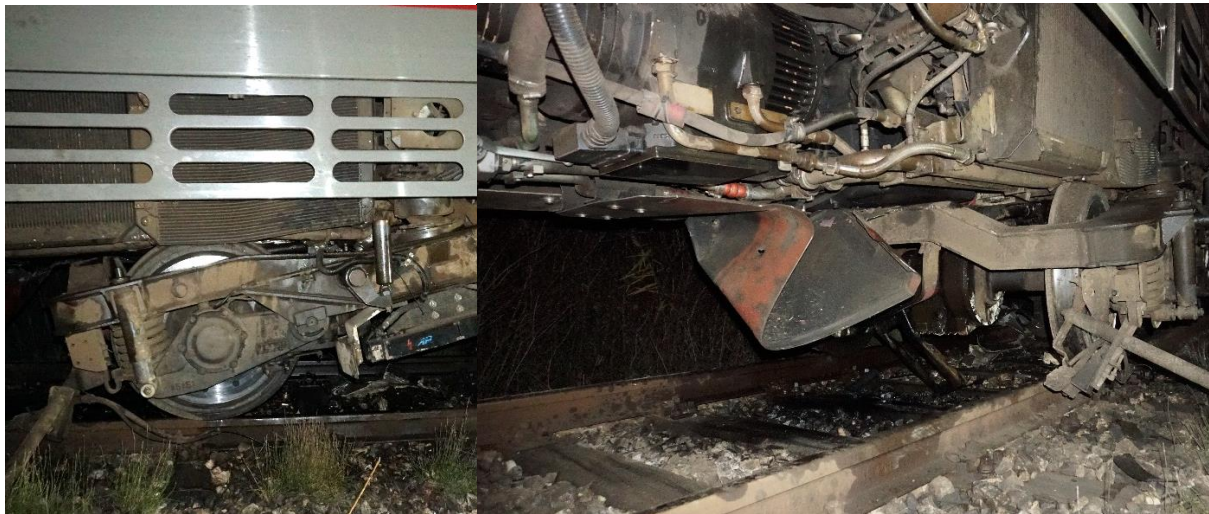
Figure 3.1.5: Appearance of damages on the power unit DMV 711-078

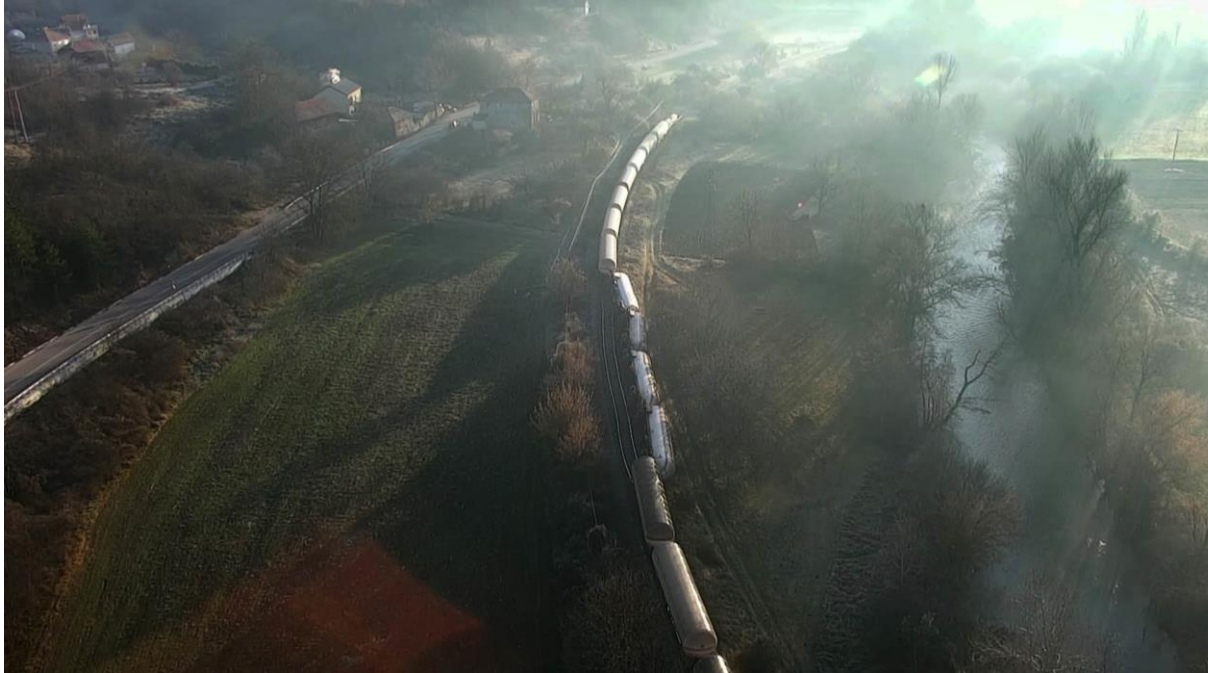
Figure 4.1.1.1: The appearance of the serious accident site (source: MUP, Emergency Situations Sector)

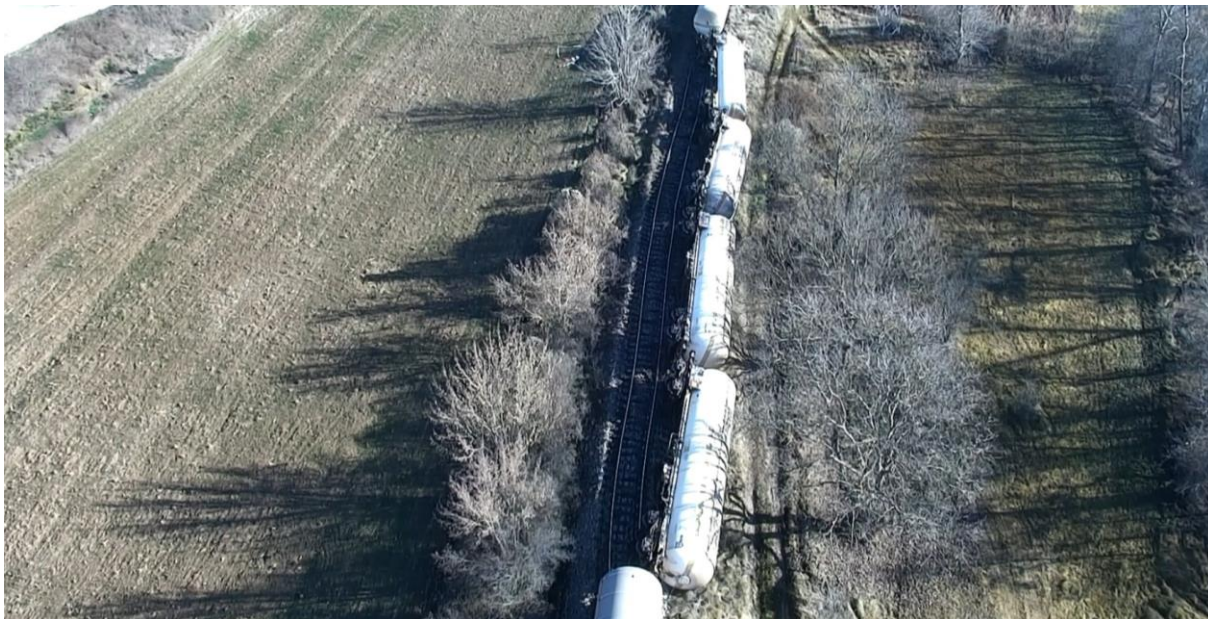
From the overturned thirteenth wagon No. 33 80 7818 081-1, there occurred ammonia leakage.

Figure 4.1.1.2: Appearance of the point of overturning of the wagons-tanks
(source: MUP, Emergency Situations Sector)

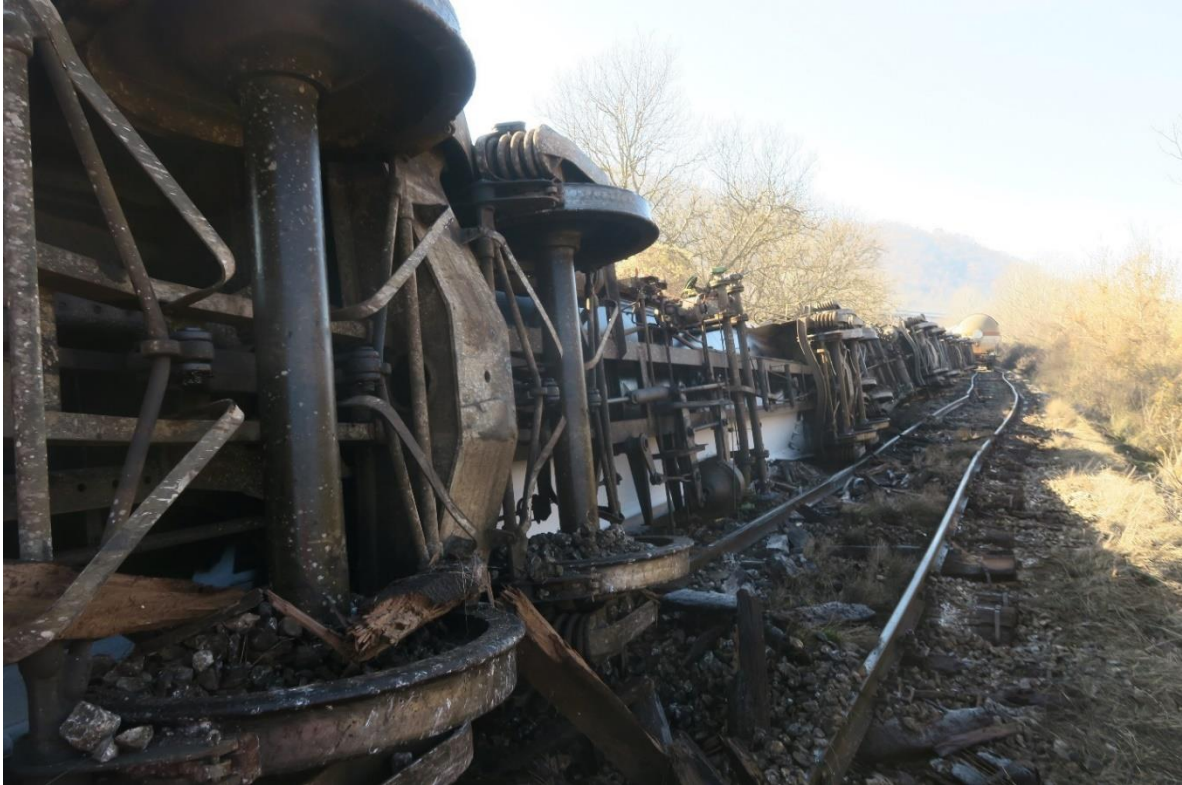
Figure 4.1.1.3: The appearance of the overturned wagon

The direct and immediate cause of the serious accident was the spreading of the rails under the load's action and the entry of the inner wheel into the track in the curve. The entry occurred due to the absence or looseness of fastening equipment on multiple consecutive sleepers, decayed or cracked sleepers, in combination with the track's geometric parameters beyond the emergency intervention limit – specifically, type “C” errors (cross level, twist, and track gauge). Due to a significant excess of cross level, the vertical load on the inner (left, in the direction of movement) wheels was increased. At the same time, the change in twist between the two values above the current intervention limit further induced oscillations around the longitudinal axis, causing even higher amplitude load on the inner wheels. Combined with the lateral guiding force in the curve, the very poor condition of the fastening equipment and sleepers led to the spreading of the rail heads and the entry of the inner wheel into the track.

SR_06/23 “IŽS“a.d. is required to, considering the inadequate maintenance and condition of the track, sleepers, and fastening equipment, conduct a risk assessment for train traffic on the main arterial line No.106: Niš - Dimitrovgrad - state border - (Dragoman) and take measures to reduce the risks to an acceptable level. Based on this, they should conduct a professional assessment of the minimum necessary resources (materials, machinery, workforce) for track maintenance.

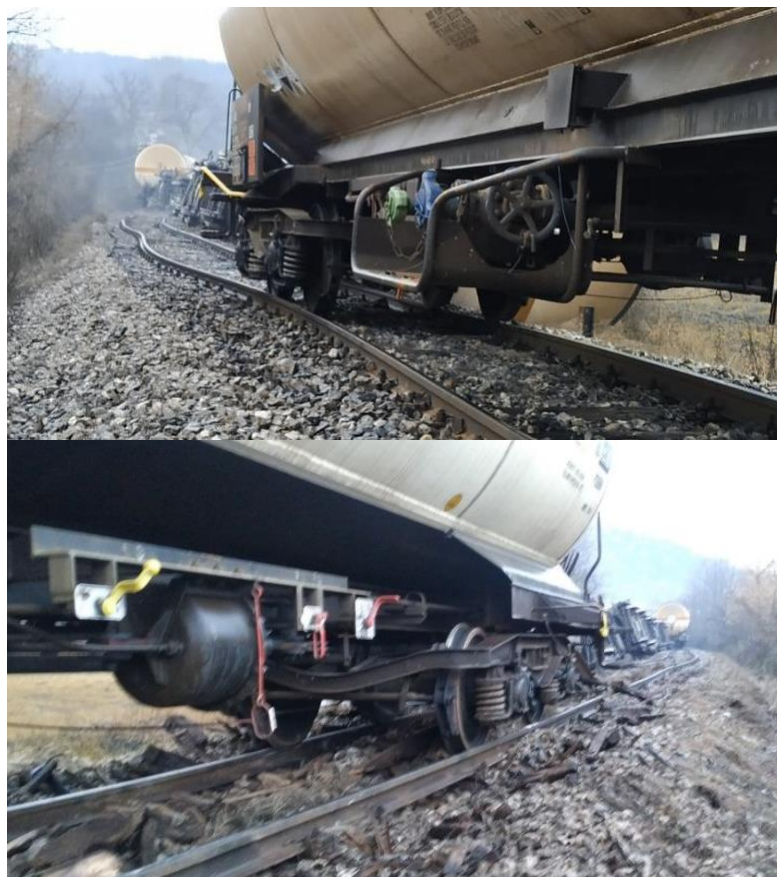
Figure 4.1.1.4: The appearance of the derailed ninth (up) and fourteen wagon (down) (source: “IŽS” a.d.)
