REPUBLIC OF SERBIA, CENTER FOR INVESTIGATION OF ACCIDENTS IN
TRANSPORT, SECTOR FOR INVESTIGATION OF ACCIDENTS IN
WATERBORNE TRAFFIC
Nemanjina 11, Belgrade

No.: 342-00-5/2024-03-4

Date: 27.12.2024.

ANNUAL REPORT FOR 2023

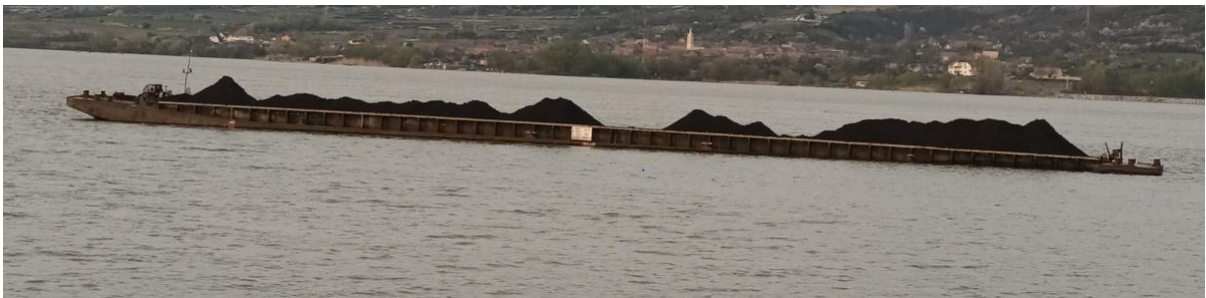
Figure 3.2.2. Pushed barge of registration No. “71771“

There is material damage to the pushed barge with registration No. "71771", the extent and nature of which will be determined after the barge is recovered.

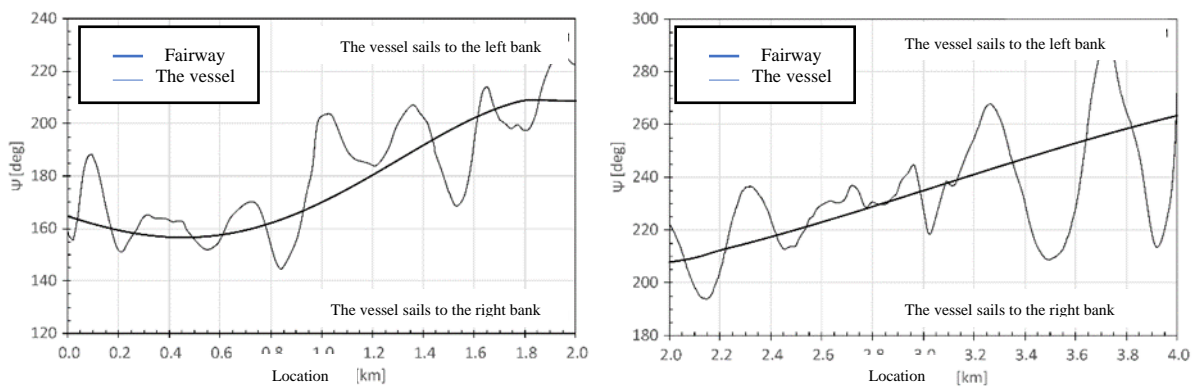
Figure 4.1.1.1. Deviation of the vessel course in relation to the fairway course on the section from 0 km – 4 km of the Sava River fairway

An examination of the trajectory of the motor cargo vessel “LEGET III“, based on the available data, reveals a significant deviation of the vessel's course from the designated fairway throughout the voyage. Specifically, for most of the time, the vessel was navigating outside the boundaries of the fairway, predominantly closer to the left riverbank, with frequent and pronounced changes in course angle. In this regard, the general overview of the navigation characteristics includes a comparison of the course angle changes (Ψ) of the motor cargo vessel “LEGET III“ relative to the optimal (required) course angle that follows the designated fairway along the analyzed sector. Given the length of the sector (11 km) and the significant fluctuations in course changes, this sector has been divided into several shorter sections, with the comparison results presented in Figures 4.1.1.1, 4.1.1.2, and 4.1.1.3.

The thick line in images 4.1.1.1 – 4.1.1.3 represents the required course angle for the vessel to follow the river's fairway while navigating upstream, while the thin line represents the recorded course change of the vessel during navigation. Moderate changes in the fairway direction, depicted by the thick line, characterize the river's natural meandering. The obtained results show that the motor cargo vessel "LEGET III" rarely follows the direction of the fairway, while for most of the time, it deviates significantly—sometimes by more than 45 degrees from the required course (the direction of the fairway). It is important to emphasize that the overlapping of the vessel's course and the fairway direction (points where the curves intersect) does not necessarily mean that the vessel is within the fairway boundaries. These are moments when the vessel briefly aligns with the required course, usually while meandering outside the fairway limits.

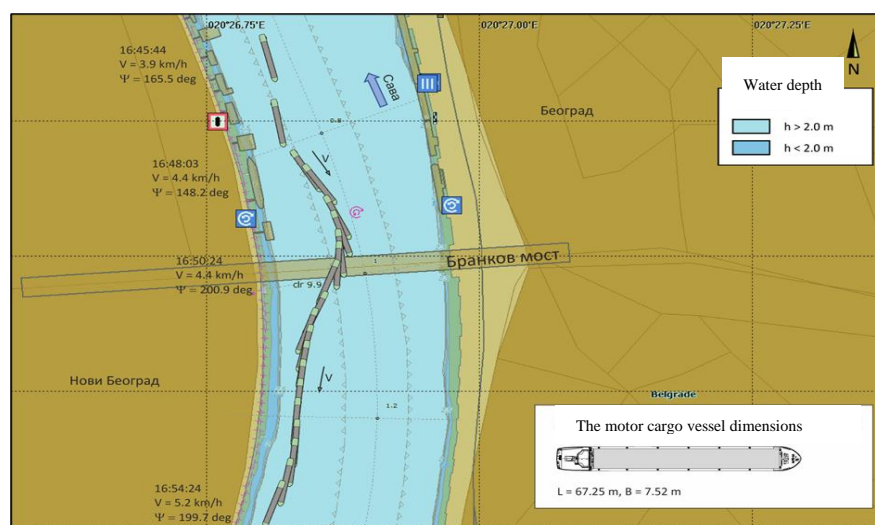
Figure 4.1.1.4. Trajectory of the motor cargo vessel "LEGET III" upon upstream navigation under the Brankov bridge

Based on the provided navigation data, it is observed that at 16:45:44 (Figure 4.1.1.4.), the vessel is located about 300 meters downstream of the bridge and is navigating within the fairway boundaries, along the left edge, at a speed of 3.9 km/h. Over the next 300 meters, while navigating upstream, the vessel briefly leaves the fairway and then, at 16:48:03, at a speed of 4.4 km/h, returns to the fairway boundaries. Just before the bridge, the vessel sharply changes course and turns to the right – towards the left bank. Thus, it passes under the bridge at 16:50:24 along the left edge of the fairway and, at a speed of 4.4 km/h, continues navigation towards the left bank, outside the fairway boundaries.

About 200 meters upstream from the bridge, approximately 40 meters from the left bank, the vessel establishes a course parallel to the bank, which can also be seen in Figure 4.1.1.1 (position 1 km + 200 m), and continues to navigate upstream for about 100 meters. Then, at 16:54:24, the vessel further turns to the right and, at a speed of 5.2 km/h, approaches the left bank at about 15 meters. This navigation can be considered potentially dangerous, considering that the ship is traveling far outside the safe boundaries of the fairway.

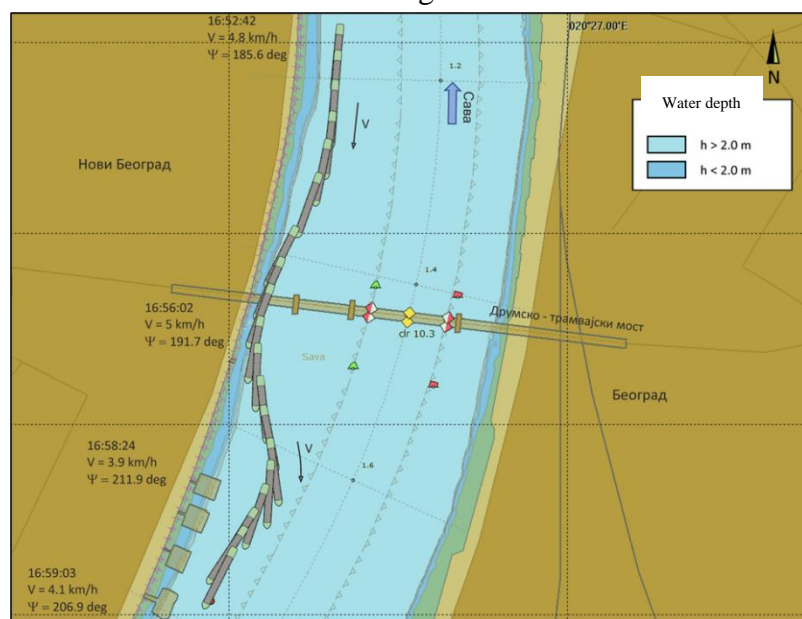
Figure 4.1.1.5. Trajectory of the motor cargo vessel “LEGET III” upon upstream navigation under the road-tram bridge

The trajectory of the motor cargo vessel “LEGET III” during its upstream navigation under the road-tram bridge is shown in Figure 4.1.1.5. The vessel passes under the bridge at 16:56:02, traveling at a speed of 5 km/h. At that moment, it is only about 15 meters away from the left bank. Here, the vessel is on the edge of a zone characterized by a depth of less than 2 meters. Such navigation can be considered extremely risky. In this sense, it can be concluded that this moment was actually the first instance when an inland navigation incident could have occurred.

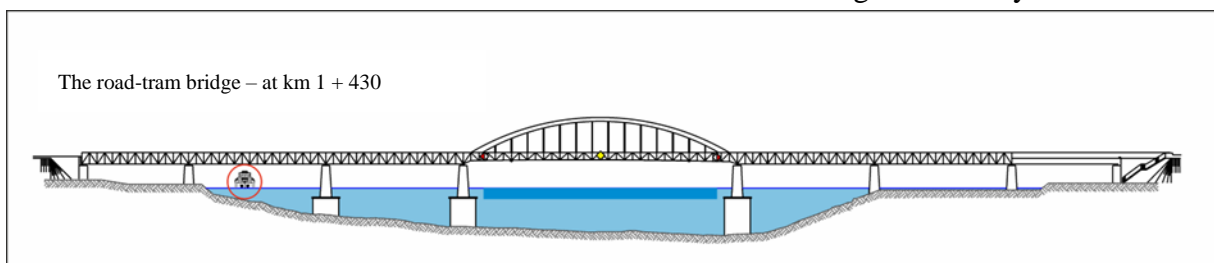
Figure 4.1.1.6. Position of the motor cargo vessel “LEGET III” in relation to the bridge profile and in relation to the fairway

The position of the motor cargo vessel “LEGET III” in relation to the bridge profile and the fairway (which is located in the middle of the bridge span) at the moment of passing under the bridge is shown in Figure 4.1.1.6. Here, it becomes clearer how close the vessel actually passed to the shore and how far it was from the safe boundaries of the navigable fairway.

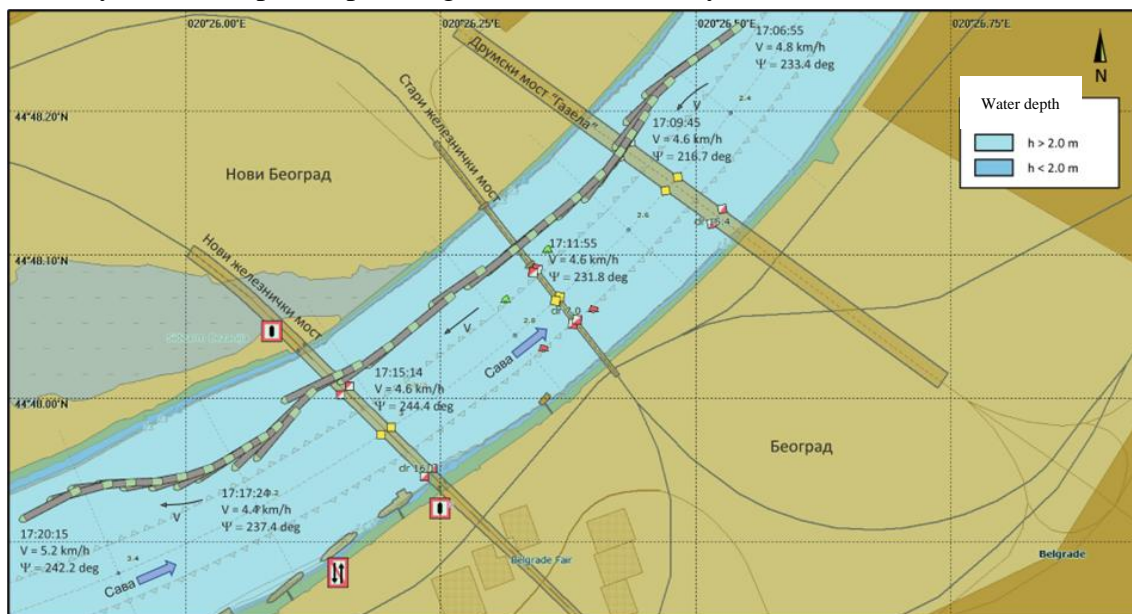
Figure 4.1.1.7. Trajectory of the motor cargo vessel “LEGET III” upon upstream, navigation under the road bridge “Gazela” and the railway bridges

Figure 4.1.1.7 shows the trajectory of the motor cargo vessel “LEGET III” along the section of the Sava River fairway between 2 km + 300 m and 3 km + 400 m. On this section, while navigating upstream, the vessel passes under three bridges: the road bridge "Gazela" (2 km + 520 m), the old railway bridge (2 km + 730 m), and the new railway bridge (3 km + 000 m).

From the reconstructed trajectory, based on the obtained data, it is clearly observed that the vessel continuously navigates outside the fairway boundaries, closer to the left bank. Between 17:09:45, when the vessel passes under the first bridge, and 17:15:14, when it passes under the last bridge (approximately 500 meters of navigation), it is noticeable that the vessel moves more steadily, without significant speed variations and following a course that does not deviate considerably from the optimal path aligned with the fairway.

Slightly greater course deviations from the river flow direction are observed before the first bridge and after passing under the third bridge. At 17:20:15, while navigating upstream at a speed of 5.2 km/h, the motor cargo vessel “LEGET III” approaches the left bank to approximately thirty meters, as shown in Figure 4.1.1.7.

Such navigation—outside the designated boundaries of the fairway and in close proximity to the bridge piers—can be considered risky, especially given that this section requires special attention due to navigation near structures of vital importance.

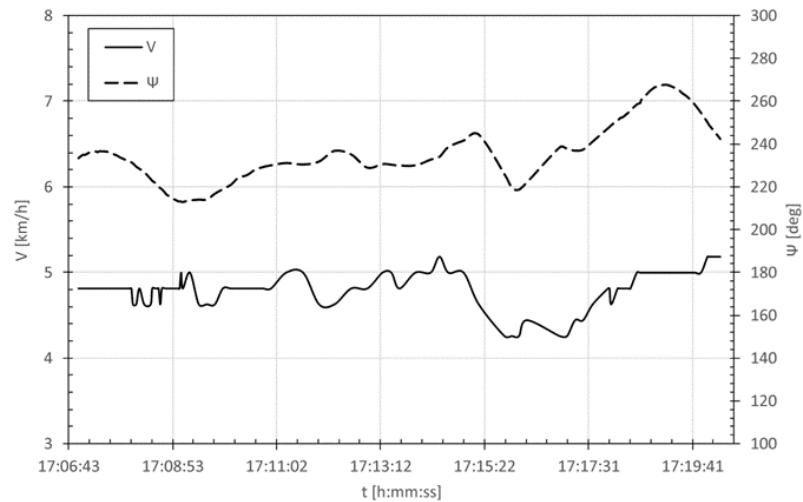
Figure 4.1.1.8. Changes in speed and course angle of the vessel on the observed section of the fairway

Changes in the vessel's speed relative to the riverbed (v) and the course angle (Ψ) along the examined section are shown in Figure 4.1.1.8. Although the recorded speed of the vessel while passing under the bridges is 4.6 km/h (see Figure 4.1.1.7), it can be observed that between the bridges, the vessel's speed fluctuates between 4.6 and 5.2 km/h. Similar to the course angle variations, slightly greater changes in speed are noticed after passing under the new railway bridge.

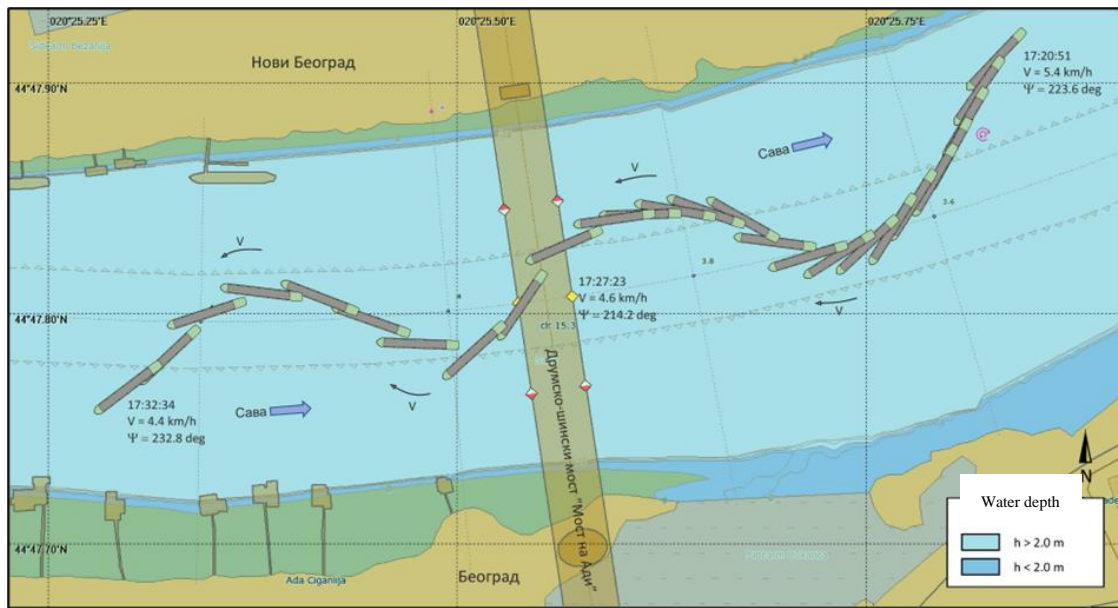
Figure 4.1.1.9. Trajectory of the motor cargo vessel “LEGET III” upon upstream navigation under the road bridge “Ada Bridge”

After passing under the new railway bridge, the motor cargo vessel "LEGET III" continues its upstream navigation, as shown in Figure 4.1.1.9. After approaching the shore to about thirty meters, at 17:20:51, while traveling at a speed of 5.4 km/h, the Ship Master makes a sharp turn to the left toward the right bank. At position 3 km + 580 m, the motor cargo vessel "LEGET III" reenters the fairway boundaries. However, although in this section the vessel mostly navigates within the fairway (compared to previously examined sections), the next 700 meters of upstream navigation are characterized by pronounced oscillations in movement, accompanied by alternating changes in speed and course. While navigating in this manner, with alternating turns to the left and right, at 17:27:23, traveling at a speed of 4.6 km/h, the vessel passes under the road-rail bridge "Ada Bridge" along the left edge of the fairway. Such navigation could be characterized as extremely unsafe.

Given the length of the examined section and the direction of the fairway span, which features a very gentle curve, such navigation indicates a significant loss of control over the vessel, which could have had far more severe consequences. The described navigation pattern, with speed fluctuations ranging between 3.5 and 5.5 km/h, also suggests a considerable loss of attention by the Ship Master or an inability to safely operate the vessel.

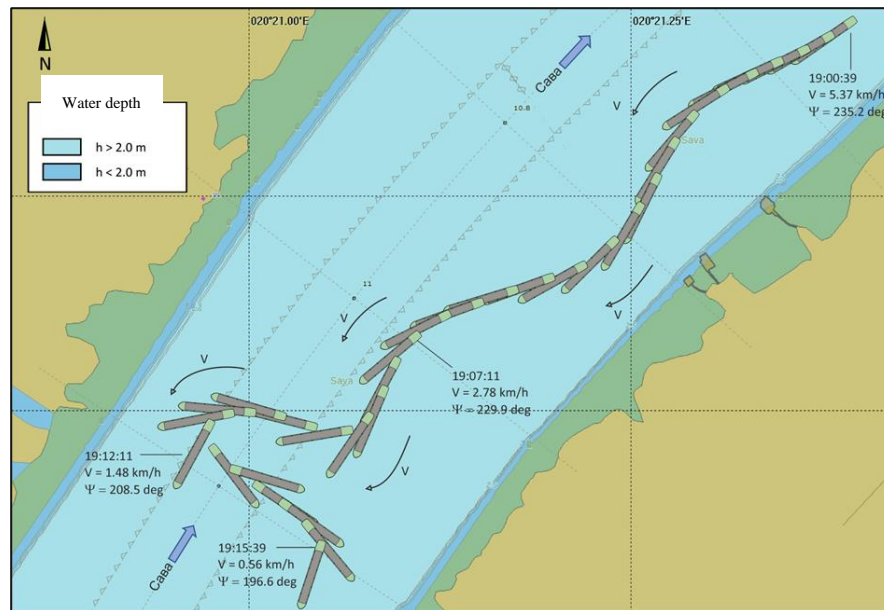
Figure 4.1.1.10. Trajectory of the motor cargo vessel "LEGET III" at the section between 10 km + 500 m and 11 km + 200 m

Special attention was also given to analyzing the navigation immediately before the location where the inland navigation incident occurred. At 19:00:39, while traveling upstream at a speed of 5.37 km/h, the motor cargo vessel “LEGET III” was navigating outside the fairway boundaries, closer to the right bank, at position 10 km + 500 m. With frequent changes in direction, alternating between the starboard and port sides (see Figure 4.1.1.10), the vessel reached position 11 km at 19:07:11, where a significant speed drop to 2.78 km/h was observed. In the next 8 minutes, the vessel’s movement was characterized by a sharp turn to the right (toward the left bank), crossing the fairway entirely, followed by a turn to the left (toward the right bank), again crossing the fairway, while gradually reducing speed. By 19:15:39, the speed had dropped to just 0.56 km/h. All of this occurred approximately 800 meters to 1 km downstream from the unloading depot position.

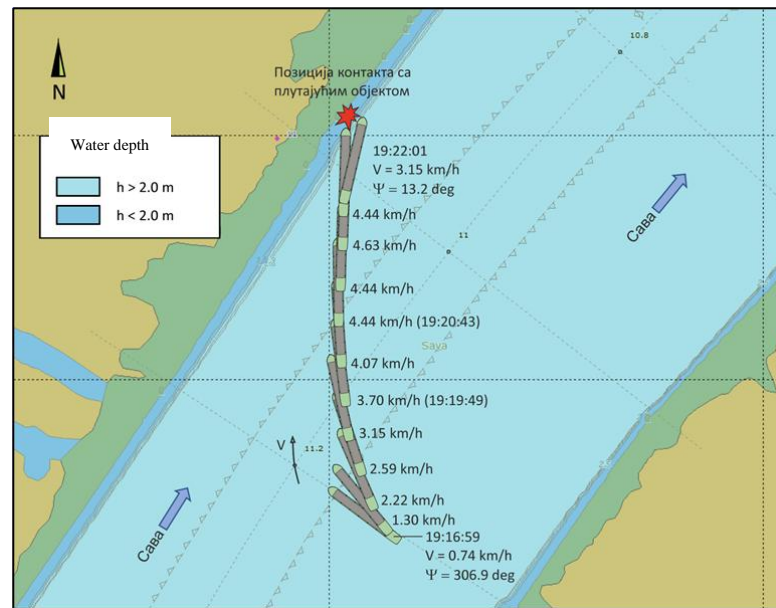
Figure 4.1.1.11. Trajectory of the motor cargo vessel “LEGET III” in the zone of the inland navigation incident

As observed in Figure 4.1.1.11, after turning to starboard, at 19:16:59, the vessel "LEGET III" starts its downstream voyage at position 11 km + 200 m. This maneuver by the Ship Master is illogical, as the unloading location (the depot in Makish) is located 800 meters upstream. The vessel, navigating downstream from the right bank toward the left, once again crosses the fairway while gradually increasing speed.

At 19:19:49, traveling at a speed of 3.9 km/h, the vessel crosses the corridor axis, and less than a minute later, at 19:20:43, at a speed of 4.44 km/h, it exits the fairway boundaries and continues navigation toward the left bank at an angle of approximately 40 degrees relative to the shore. At that moment, the vessel's bow was approximately 45 meters from the shore. Without changing course, the vessel continued navigating toward the left bank, increasing its speed to 4.63 km/h. At 19:21:47, the first speed reduction was observed, dropping to 4.44 km/h. Fourteen seconds later, at 19:22:01, the vessel's recorded speed was 3.15 km/h. From this, it can be concluded that during this time interval, the bow of the motor cargo vessel "LEGET III" made contact with a floating structure moored along the left bank. This was also when a change in the vessel's course angle occurred, as it had previously been navigating at $\Psi=1.8^\circ$ (practically northbound, or directly toward the shore)

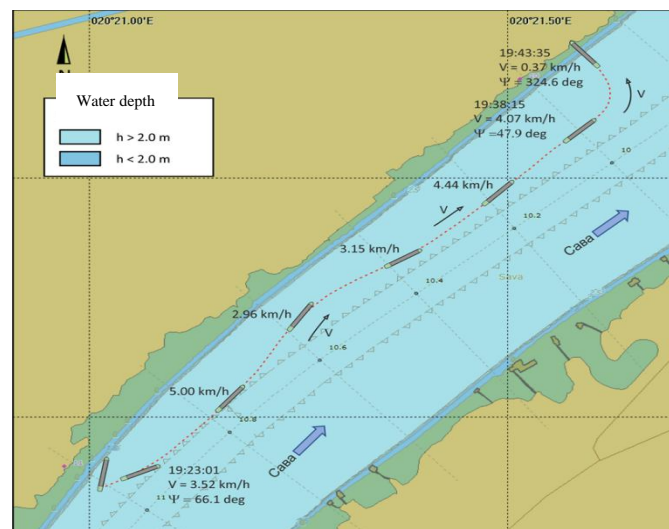
Figure 4.1.1.12. Trajectory of the motor cargo vessel “LEGET III” after the inland navigation incident

After the impact with the floating structure, a decrease in the vessel’s speed was observed, but it did not come to a stop. Considering that the speed dropped from 4.44 km/h to 3.15 km/h at the moment of impact and then began to increase again (see Figure 4.1.1.12), it could be concluded that the observed speed reduction was actually a consequence of the vessel’s collision with the floating structure, rather than a measure taken by the captain to control the engine’s RPM.

As observed from Figure 4.1.1.12, following the inland navigation incident – as the bow of the vessel "slid" down the floating object, the vessel began to move away from the left bank and experienced a slight increase in speed. At position 10 km + 780 m, the motor cargo vessel "LEGET III" was already sailing downstream at a speed of 5 km/h along the left edge of the fairway, moving away from the site of the navigation incident. The vessel then turned again towards the left bank at position 10 km + 700 m, and around 19:30, its speed dropped below 2.5 km/h. After this speed reduction, the vessel's speed began to increase again. However, now (downstream from position

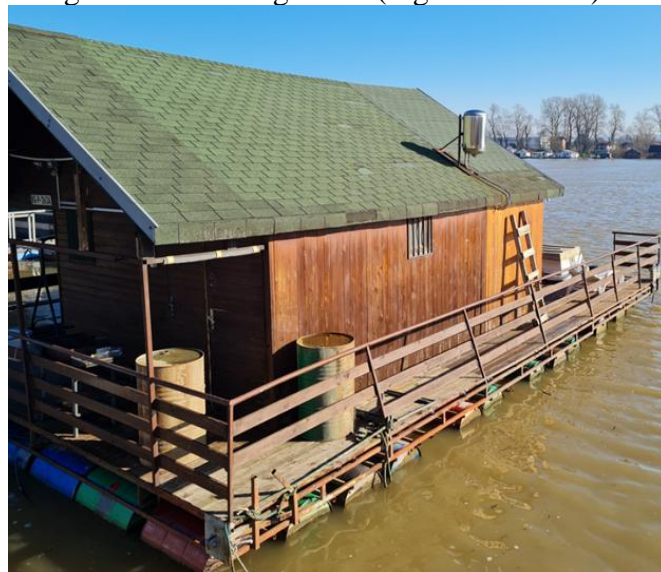
Figure 4.1.1.13.

- On the upstream lateral side of the impact, the deck railing, made of metal tubular profiles, suffered longitudinal bending deformation along the entire length of the side, $L = 11.5$ m (Figure 4.1.1.13.);
- Five (5) vertical supports, each $L = 0.9$ m in length and welded to the deck structure, experienced longitudinal bending stress (Figure 4.1.1.13.).

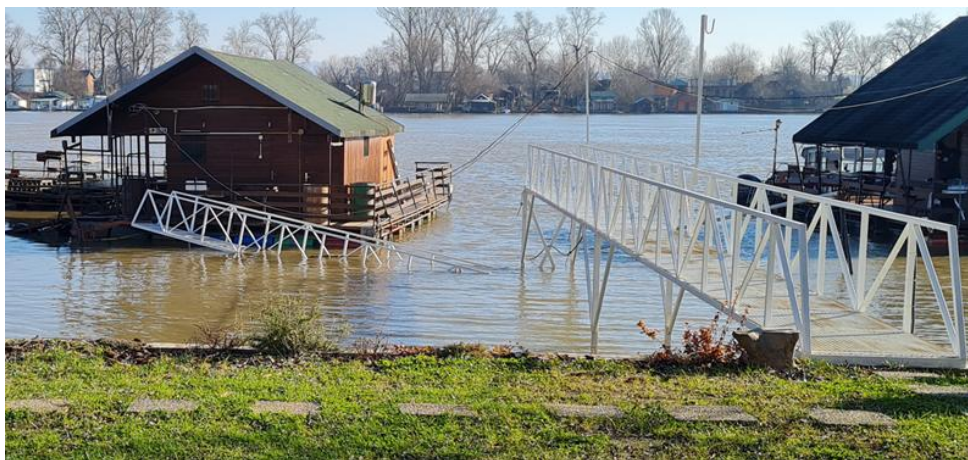
Figure 4.1.1.14.

- A segment of the access bridge (metal structure), $L = 9$ m in length, which connects to the previous segment, detached and fell into the water. The other end became separated from the deck structure of the floating house and is now suspended above the water surface (Figure 4.1.1.14.).

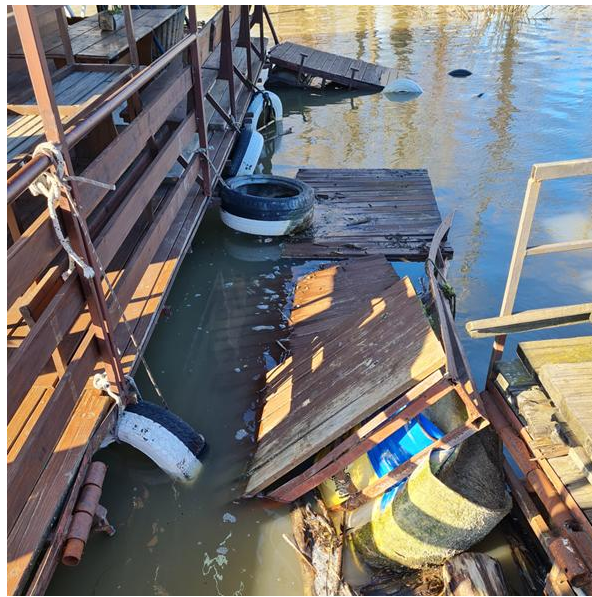
Figure 4.1.1.15.

- Along the downstream side of the floating house, two pontoon walkways on barrels were damaged (Figure 4.1.1.15.).

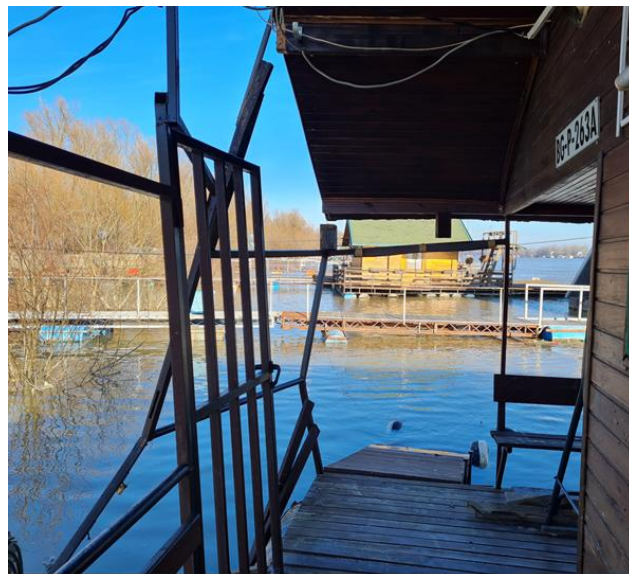
Figure 4.1.1.16.

- The entrance opening with a metal gate structure suffered deformation, along with the vertical structure, which, together with the vertical supports, holds the edge of the roof structure (Figure 4.1.1.16).

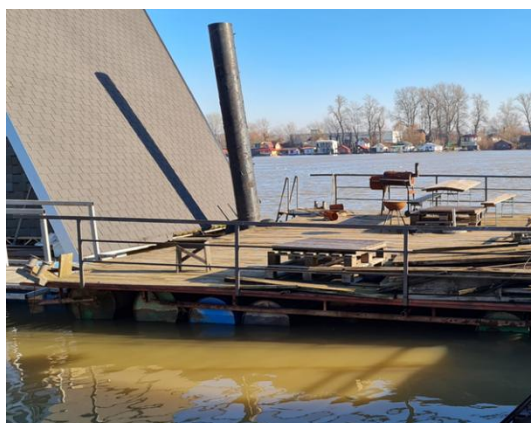
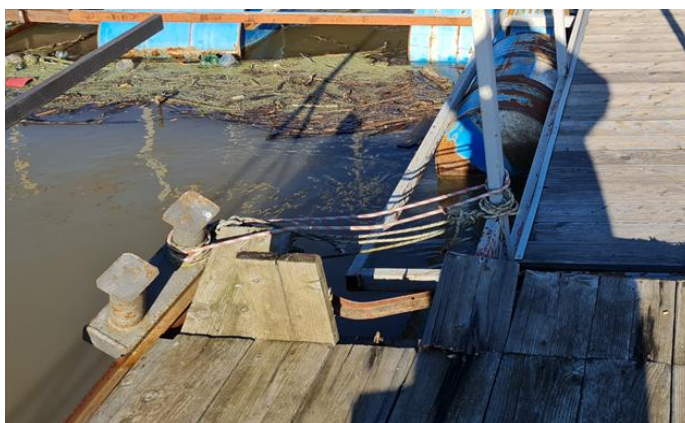
- The downstream terrace on barrels, without a registration No, sustained damage to the support point of the double-post bollard structure and deformation of the structure to which it was welded (Figures 4.1.1.17. and 4.1.1.18.).
- Upon inspection of Floating Permit No. 342-24-263/08-02, issued on June 25, 2008, by the Belgrade Harbor Master's Office, it was found that the permit was valid until September 8, 2012.
