**REPUBLIC OF SERBIA**  
**CENTER FOR INVESTIGATION OF ACCIDENTS IN TRANSPORT**  
**SECTOR FOR INVESTIGATION OF ACCIDENTS IN RAILWAY TRAFFIC**  
**BELGRADE**

**No.: 340-00-5/2026-02-31**

**ANNUAL REPORT**  
**FOR 2025**

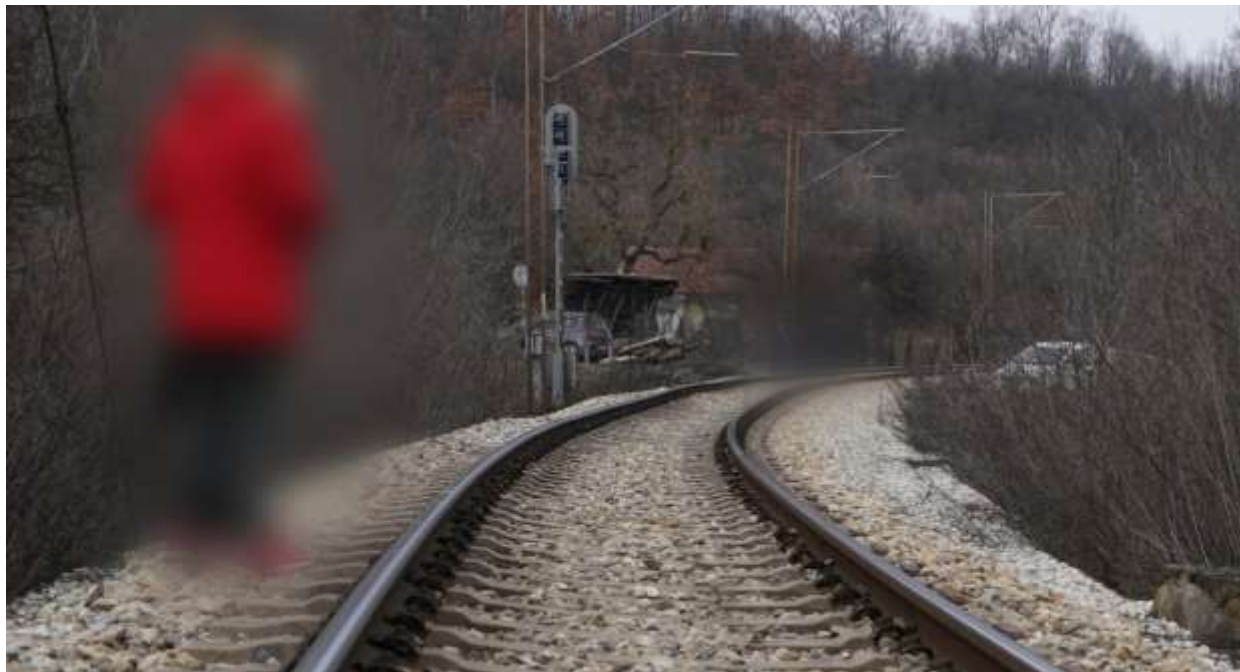
Sulfuric acid leaked from the tank of the overturned wagon through the manhole cover of the tank vessel.

**Fig. 3.1.1:** View of the derailment site (looking in the direction of train travel)

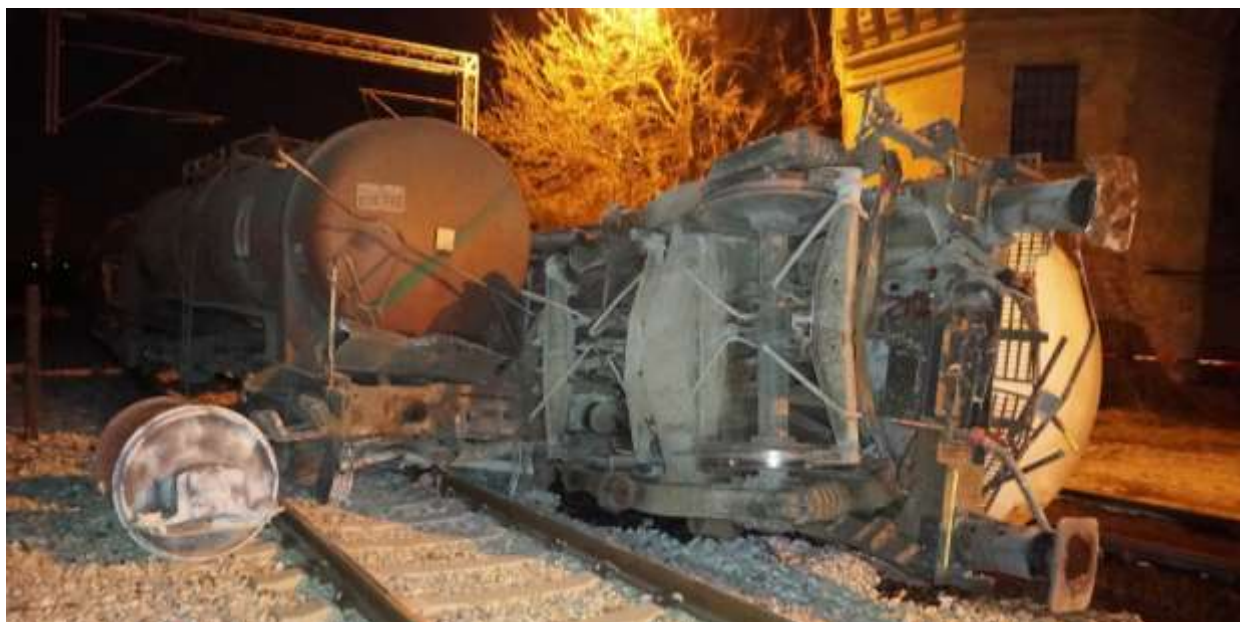
**Fig 3.1.2:** Review of the place of overturning of wagons

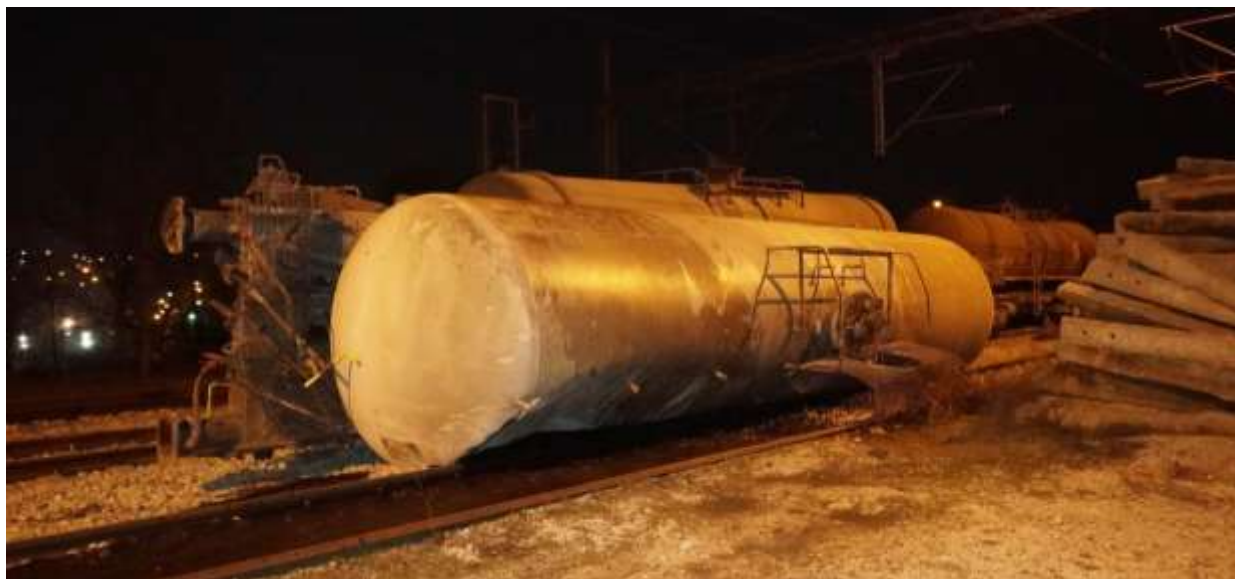
**Figure 3.1.3:** Review of the place of overturning of wagons

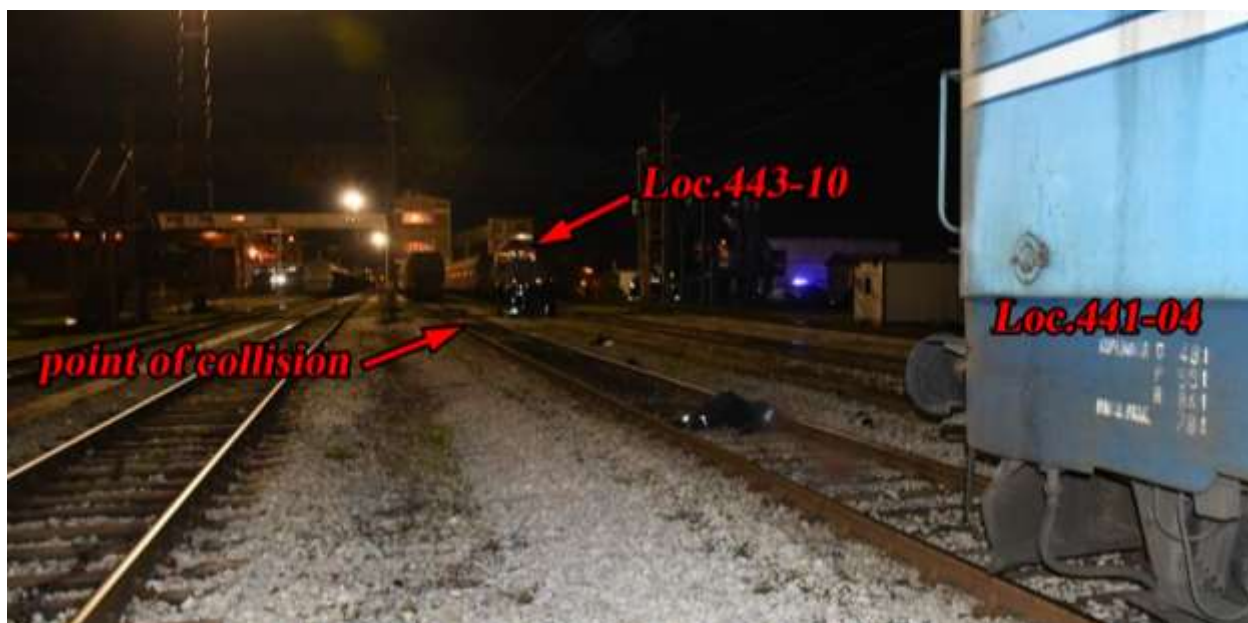
**Figure 3.2.1:** Appearance of the place of the serious accident

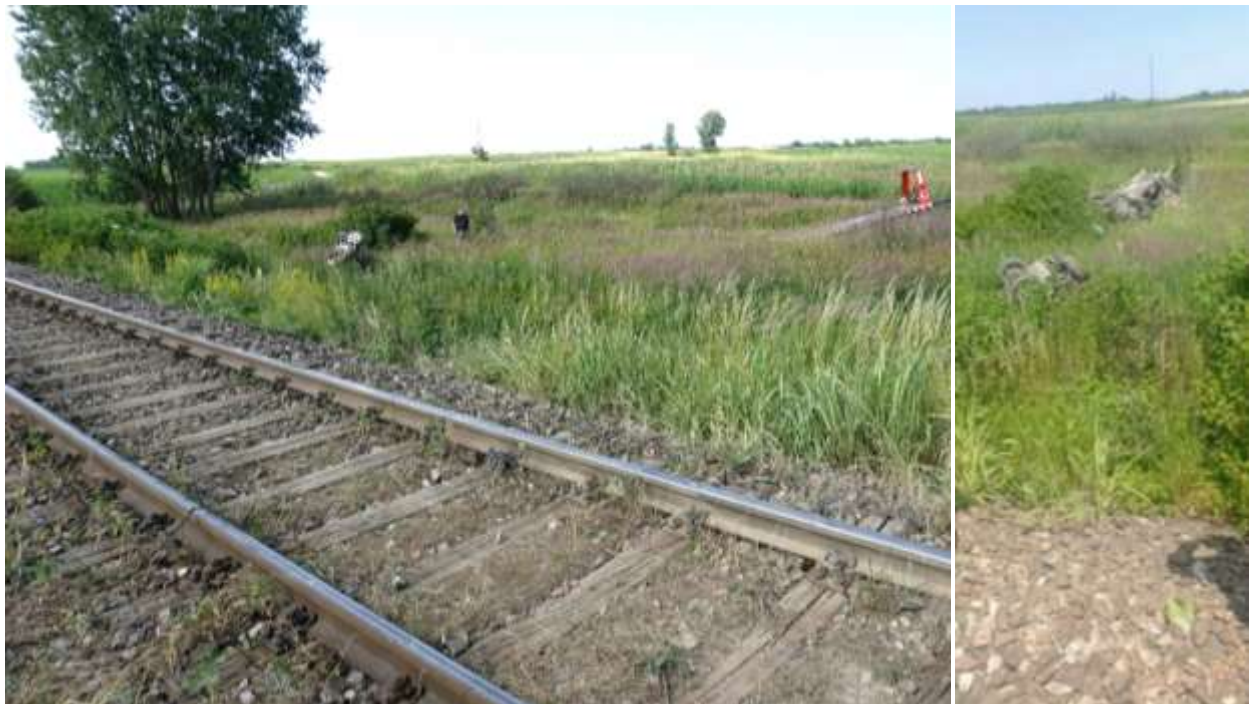
**Figure 3.3.1:** Reivew of the location where the road passenger vehicle came to a stop following the serious accident

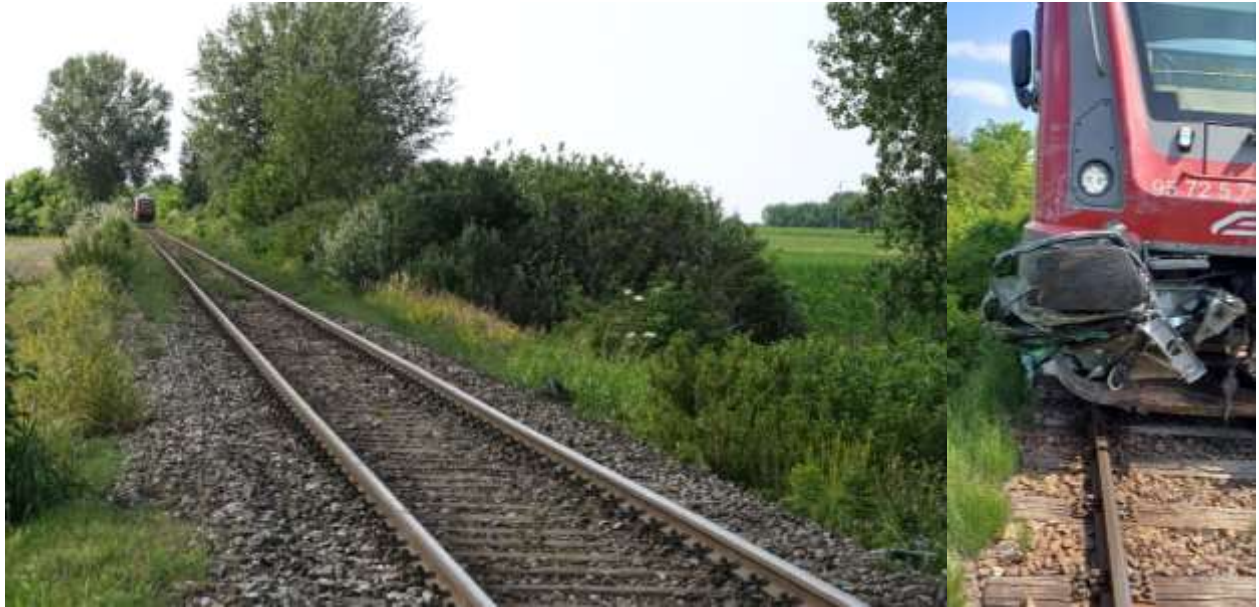
**Figure 3.3.2:** View of the stopping location and Train No. 25442

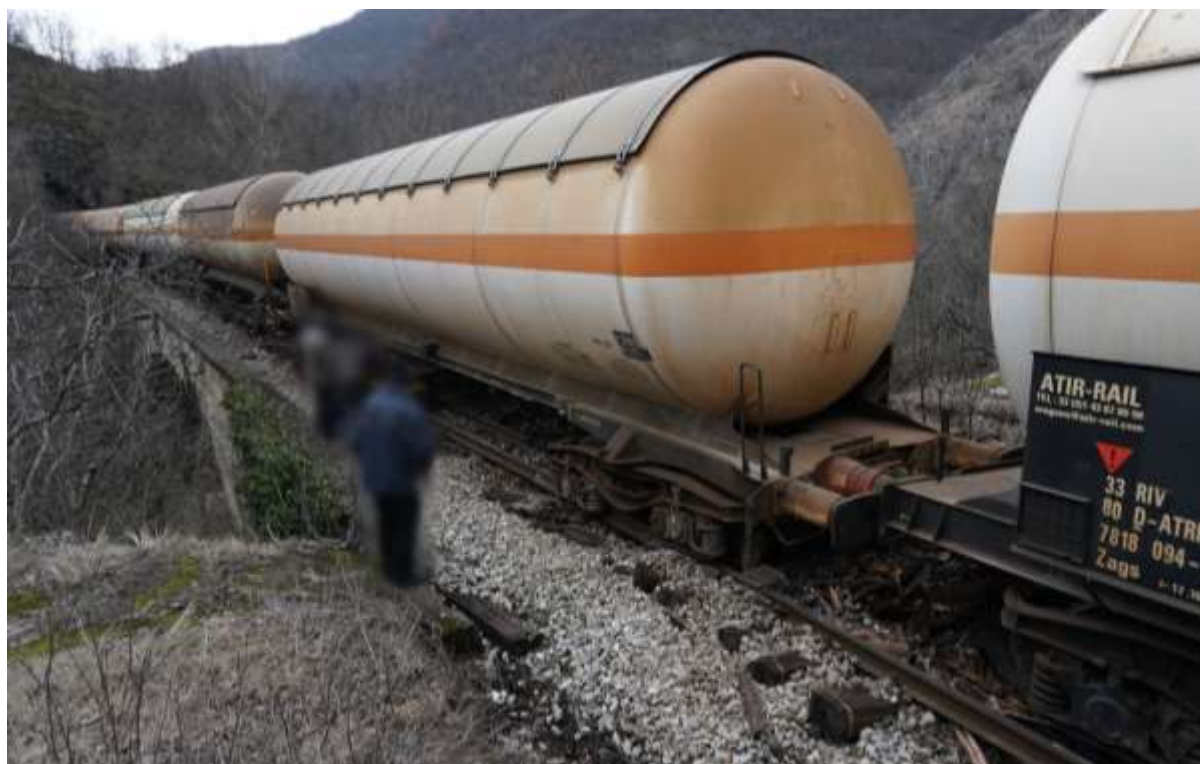
**Figure 4.1.1.1:** Review of the derailment point (concrete bridge between Tunnel No. 21 and Tunnel No. 22)

The direct and immediate cause of the accident was the spreading of the rails under load and the inner wheel falling into the track in a curve. The wheel fall occurred due to the unsatisfactory condition of the track in the section where the accident took place. In the narrowest area of the derailment, there was a lack of or loose fastening and connecting equipment, decayed and cracked sleepers in sequence, combined with deviations in track geometry: rail spreading (deviation +40 mm), cant (deviation - 42 mm) and twist (deviation 36 mm), which is above the limit for urgent intervention - that is, the error of type “C”.

- SR\_01/25** The Directorate for Railways should, as soon as possible, amend the current Regulation on the Maintenance of the Super and Structure of Railway Tracks (“Official Gazette of RS” No. 39/2023) to define the limit states of track elements requiring immediate rectification or track closure until the unacceptable condition is resolved. Additionally, the regulation should stipulate that in cases of “Type C” defects or those exceeding the “IAL” (Immediate Action Limit) for track widening and twist, speed reduction cannot be considered a measure to mitigate the risk of derailment. Instead, only urgent intervention or track closure should be undertaken.

- SR\_02/25** The Directorate for Railways, in accordance with Article 37 of the Law on Railway Traffic Safety (“Official Gazette of RS” No. 41/18), should amend and supplement the Regulation on Technical Conditions and Maintenance of the Railway Telecommunications Network (“Official Gazette of RS” No. 68/21). In Section II: Technical Conditions for the Railway Telecommunications Network, the regulation should define the minimum technical requirements for equipping railway lines with telecommunication devices to ensure reliable communication between traffic control personnel and train drivers. These requirements should be based on factors such as train speed, track categorization, volume of railway traffic, and similar considerations.

- SR\_03/25** “IŽS” a.d, should amend and supplement the Instruction on Unified Criteria for Track Condition Control on the Railway Network (Instruction 339, “Official Gazette of the ZJŽ” No. 2/2001 and 4/2004). The amendments should stipulate that in cases of “Type C” defects or those exceeding the “IAL” (Immediate Action Limit), for track widening and twist, speed reduction cannot be considered a measure to mitigate the risk of derailment. Instead, only urgent intervention or track closure should be implemented.

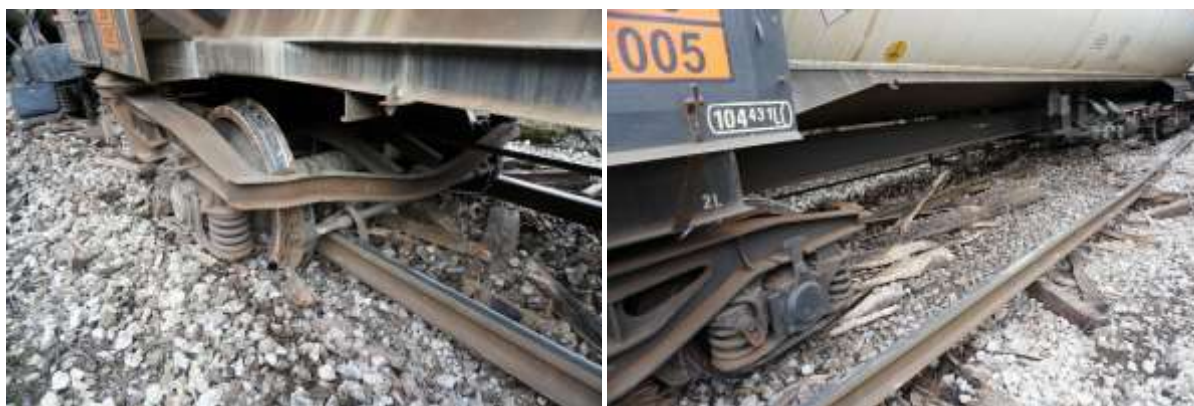
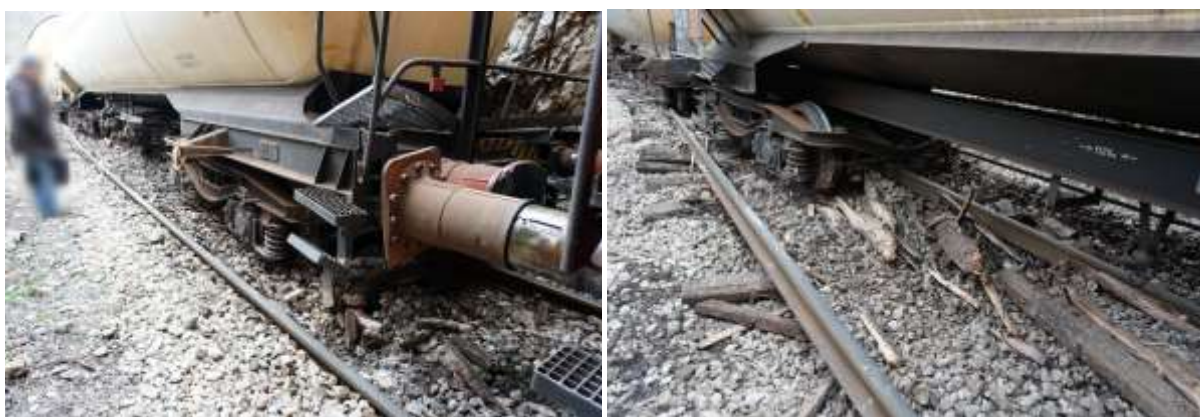
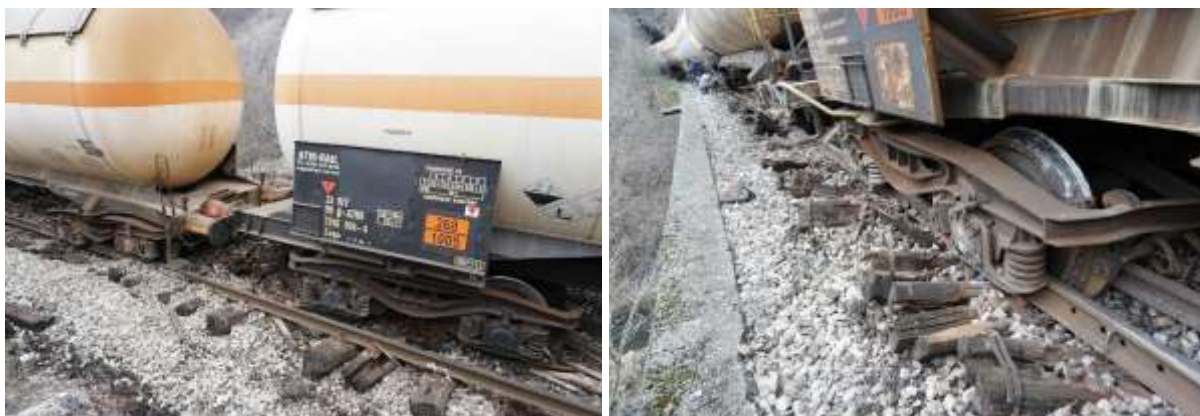
**Figure 4.1.1.2:** Review of the parts of the derailed wagons

Following the derailment, the train continued for another 85 m before coming to a stop. The derailed wagons were found within the track area, remaining upright on their wheels. There was no tilting or overturning of the wagons, and there was no leakage of the cargo.

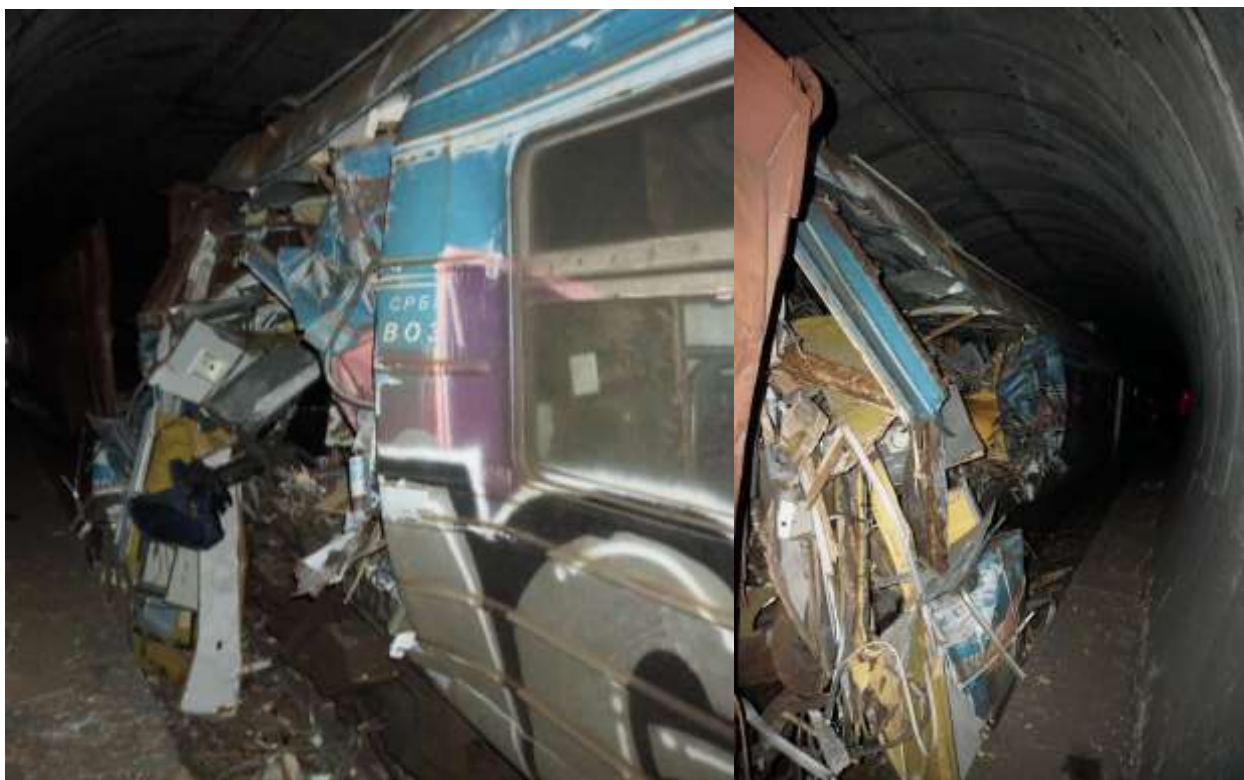
**Figure 4.2.1.1:** Damage to the front section of motor coach 412-005 of train No. 7112 after the accident

The direct cause of the accident is that two trains were at the same time on a one block section, where one train was standing still (train No 52601), while the other train was moving (train No 7112), which is contrary to the provision of paragraph 3 of Article 122 of the Traffic Rulebook (“Official Gazette of RS” No. 34/22 and 107/22).

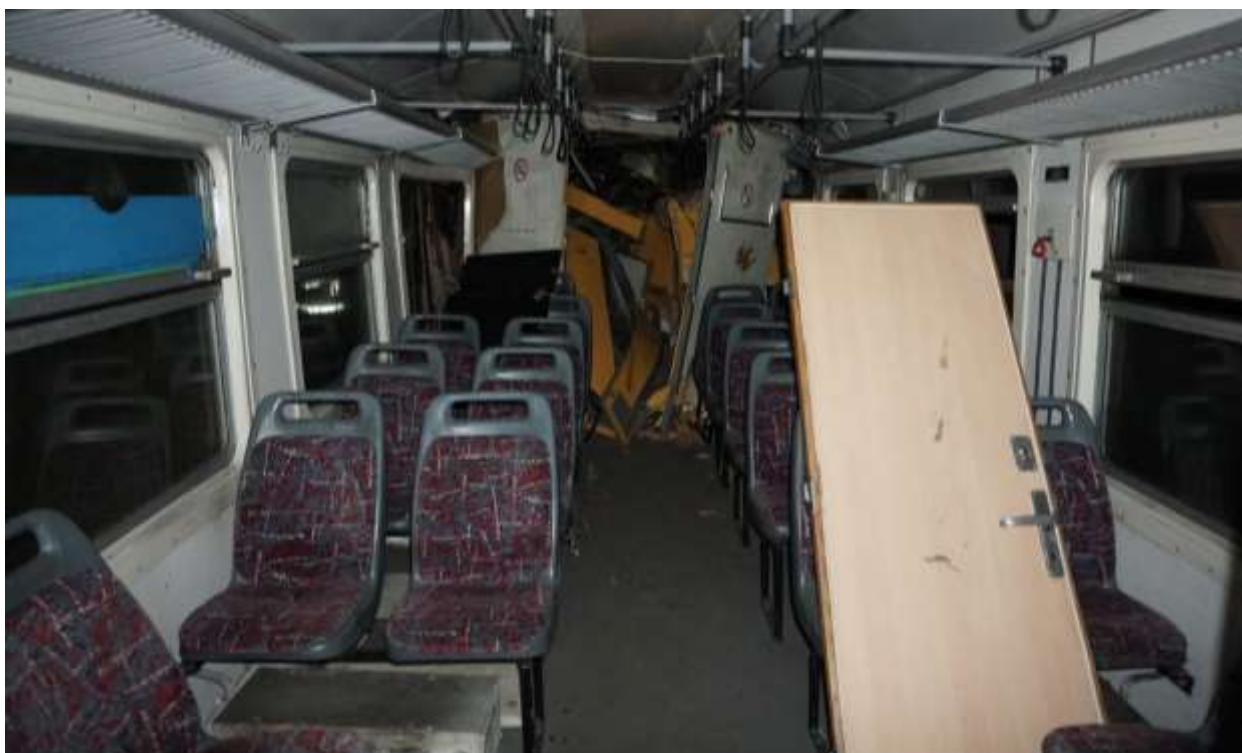
**Figure 4.2.1.2:** Deformations in the passenger compartment of motor coach 412-005 of train No.7112 after the accident

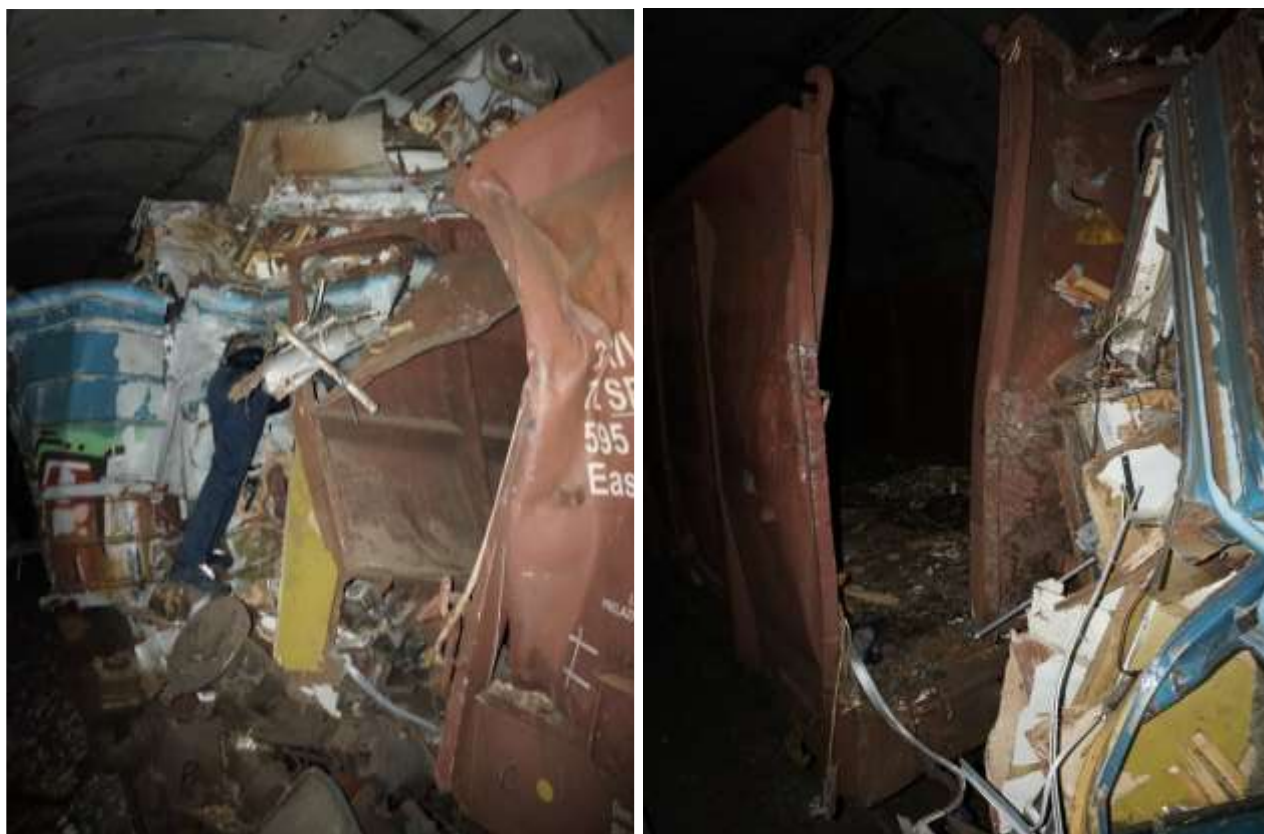
**Figure 4.2.1.3:** Deformation of wagon No. 31 72 5959 453-7 of train No. 52601 after the accident
