REPUBLIC OF SERBIA
CENTER FOR INVESTIGATION OF ACCIDENTS IN TRANSPORT
SECTOR FOR INVESTIGATION OF ACCIDENTS IN WATERBORNE TRAFFIC
Nemanjina 11, 11000 Belgrade

No.: 342-00-5/2025-03-9

Date: 29.12.2025

ANNUAL REPORT FOR 2024

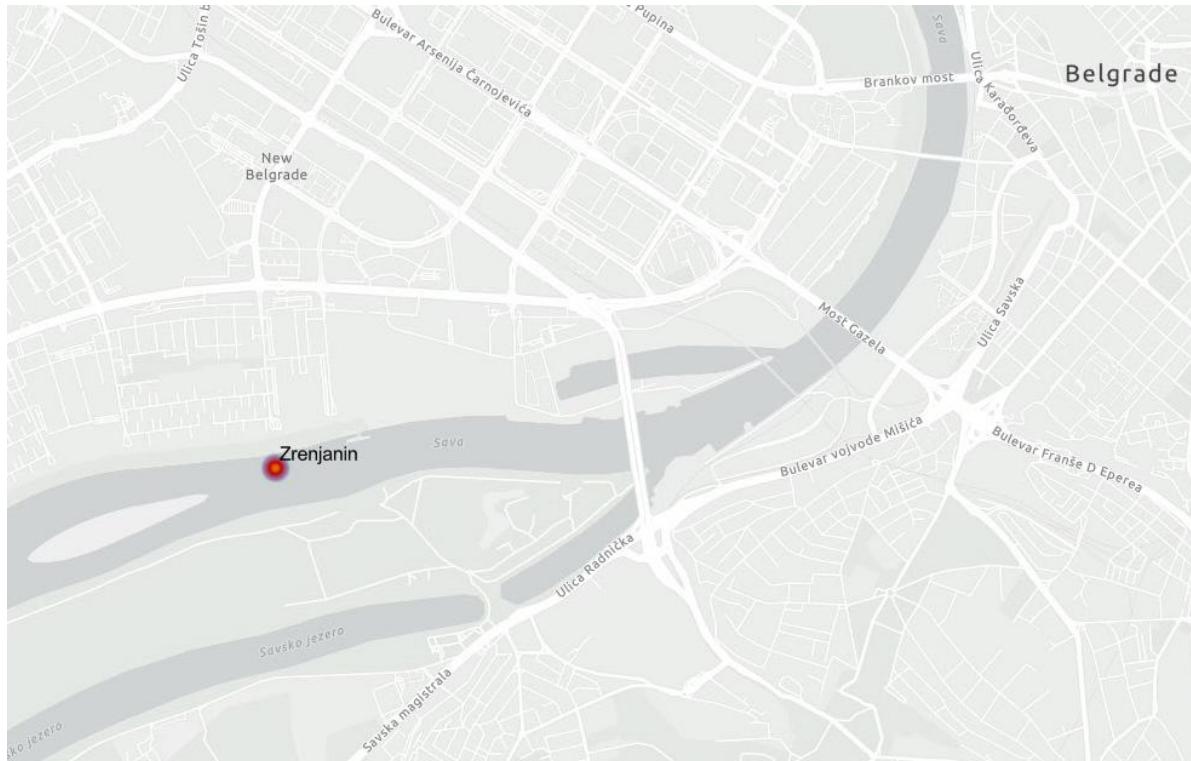
Figure 3.1. Location of the inland navigation incident

S. No.	Type	Date	Description	Location	Fatally injured	Seriously injured
1.	Inland navigation incident of the vesel "ZRENJANI N"	05.07. 2024	collision	The Sava River at around 5 km + 550 m	2	0

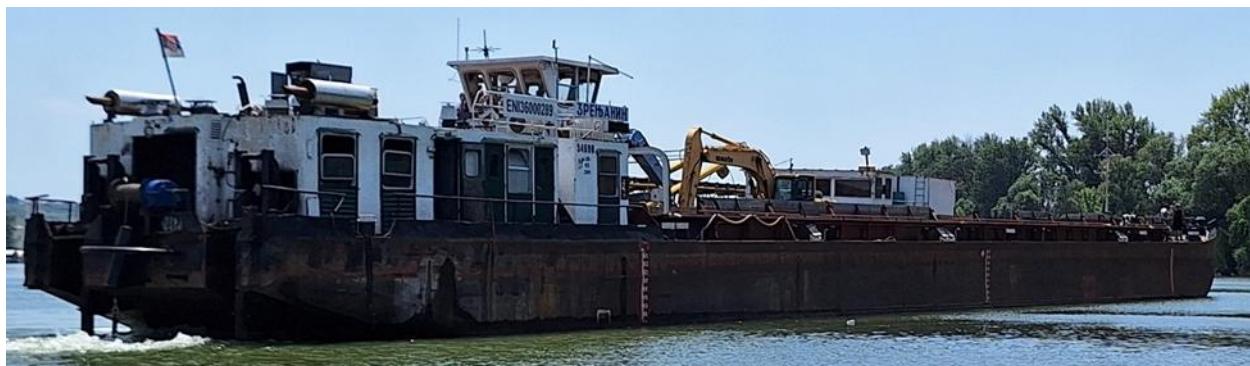
Figure 3.1.1. The motor cargo vessel “ZRENJANIN”

On 05 July 2024, at around 21:40, at approximately river kilometer 5 + 500 m on the Sava River, an inland navigation incident occurred—a collision between the motor cargo vessel “ZRENJANIN”, flying the flag of the Republic of Serbia, and the motorboat with registration No. “BG-193 B”, which is entered in the Register of Boats of the Belgrade Port Authority. On that occasion, two persons from the said motorboat drowned.

There is no material damage to the motor cargo vessel “ZRENJANIN” **or to the technical floating structure—the elevator “ZLATICA”—in the side formation.** The material damage to the motorboat “BG-193 B” will be determined after the boat is salvaged.

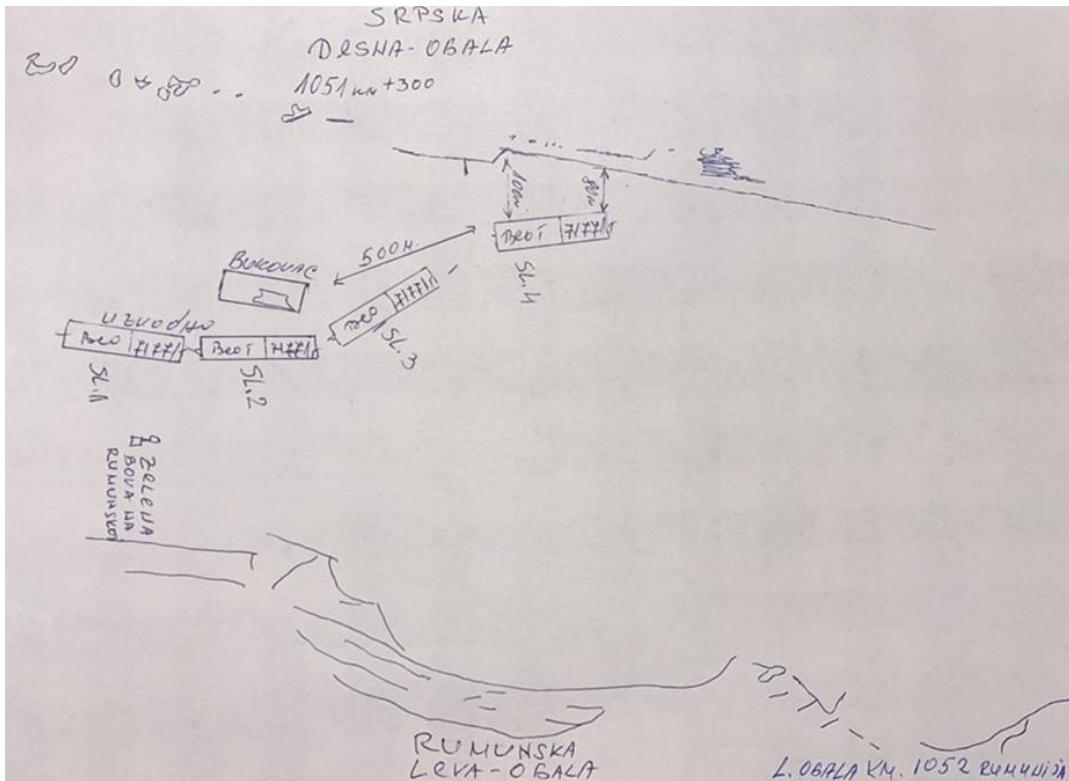
Figure 4.1.1.2.

According to the data from the Report and the Supplement to the Report of the shipmaster of the vessel “BEO,” in its upstream composition it was pushing the loaded barge with registration mark “71771.” The composition proceeded upstream from the Romanian port of Turnu Severin, where coal had been loaded for the Port of Smederevo. On 06 April 2023, at around 12:30, at position 1051 km of the navigation channel, according to the master’s statement, a sudden jolt of the composition was felt at one moment, similar to a situation when the securing ropes give way. The master immediately sent a sailor to carry out a visual inspection of the vessel and the barge. According to the master’s Report, during the inspection of the ship’s ropes, the sailor noticed that they had slackened, and then, by waving his hand, indicated to the master to steer the composition toward the right bank, while at the same time noticing water ingress into the cargo barge. After receiving information about the water ingress into the barge, according to the Report, the shipmaster, after passing the dredger (a technical floating object, bucket-type) “BUKOVAC,” steered the composition across the steel cable that carries the dredger’s main anchor. In order to prevent a possible sinking of the barge, the master grounded the bow of barge “71771” on the right bank and dropped the bow anchor at 1051 km + 300 m (Figures 4.1.1.2 and 4.1.1.3).

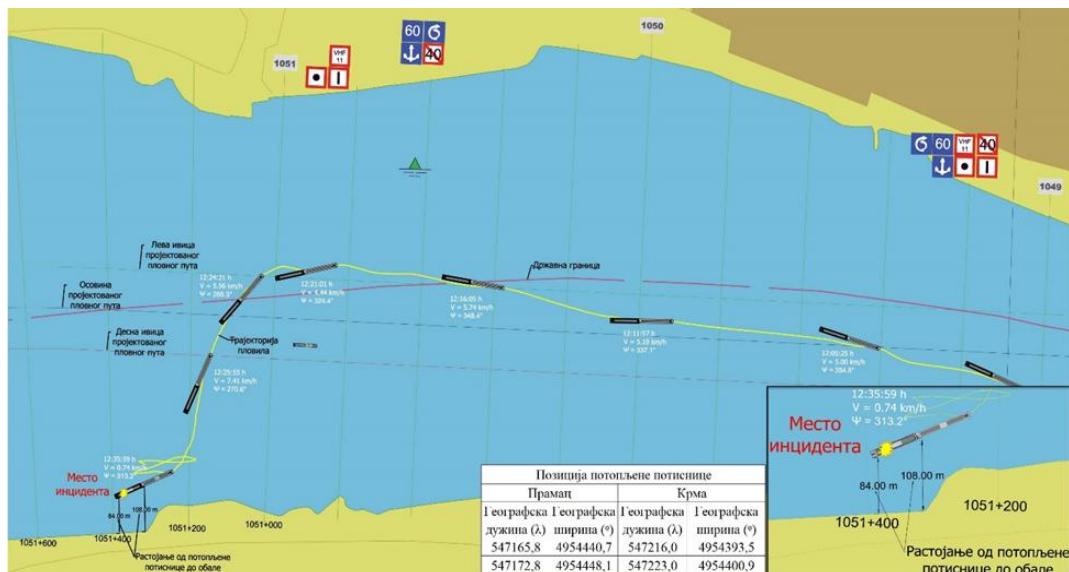
Figure 4.1.1.3.

Based on the table provided in the annex showing the projected position of the sunken pusher "71771" (Figure 4.1.1.3, page 12), the coordinates of geographic longitude (ϕ) and latitude (λ) are given, as well as a distance of 108 m from the right bank. In this sector of the waterway, the navigation corridor gravitates toward the right bank, and it should be noted that exploitation areas for natural gravel extraction extend across this part of the water area. Particular attention should be paid to technical vessels—dredgers—which move within the exploitation field during natural gravel extraction operations. In the dredger working zone, vessels and vessel composition perform technical and handling operations, including anchoring, positioning of floating units for loading, formation of convoys, and similar activities. As an additional risk factor for navigation safety, hydrometeorological conditions for navigation should also be taken into account. Considering all of the above and the position of the sunken pusher, it can be concluded that the sunken object constitutes a hazard and an obstruction to navigation.

SR_01/24 It is recommended that the shipowner/operator of the pusher bearing registration mark “71771” submit an application to the competent Port Authority of Veliko Gradište for the issuance of a Permit for the salvage (raising) of the sunken pusher, in accordance with Article 76, paragraphs 1, 2, 3, and 6, and Article 79, paragraph 2 of the Law on Navigation and Ports on Inland Waters (Official Gazette of the Republic of Serbia Nos. 73/10, 121/12, 18/15, 96/15, 92/16, 104/16, 113/17, 41/18, 95/18, 37/19, 9/20, and 52/21).

SR_02/24 It is recommended that the competent Port Authority of Veliko Gradište issue a Decision requiring the owner/shipowner, within an appropriate time limit, to remove the sunken object—in this case, the pusher bearing registration mark “71771”—in accordance with Article 78, paragraphs 1, 2, and 3, and Article 79, paragraph 2 of the Law on Navigation and Ports on Inland Waters (Official Gazette of the Republic of Serbia Nos. 73/10, 121/12, 18/15, 96/15, 92/16, 104/16, 113/17, 41/18, 95/18, 37/19, 9/20, and 52/21).

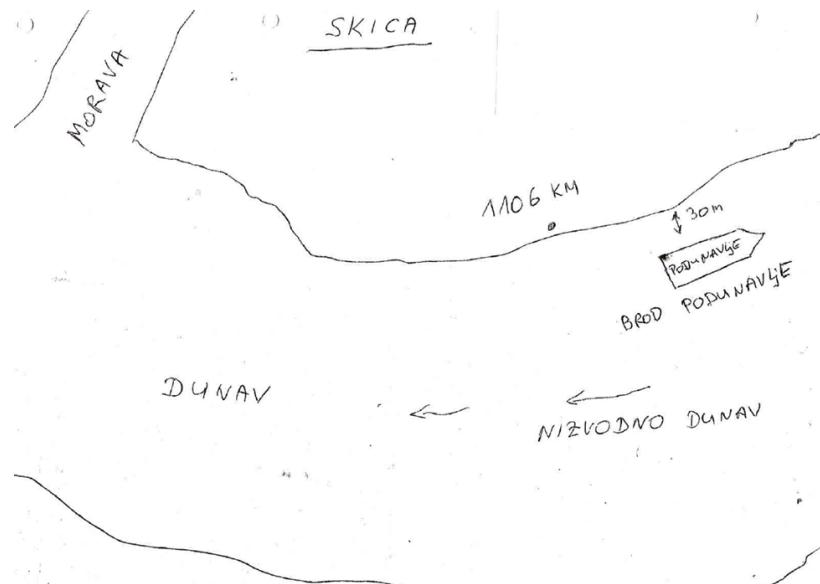
Figure 4.2.1.2.

at around 21:00, when the vessel was anchored closer to the right bank, according to the sketch, about 30 m from the shore at river kilometer 1106 (Figure 4.2.1.2).

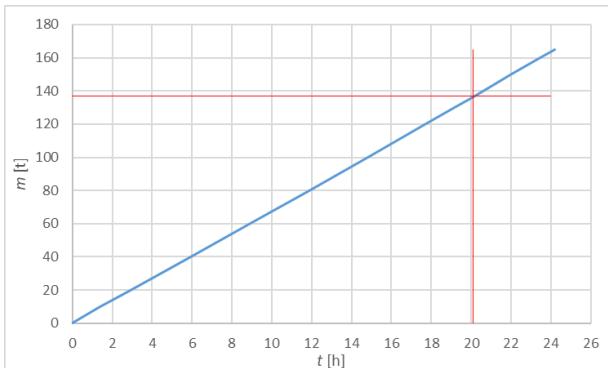
Due to the relatively small diameter of the pipelines, as well as significant local losses, a longer flooding time required for the deck to become submerged was expected. Figure 4.2.1.8 shows the change in the loaded mass of water as a function of time. Indeed, using the presented calculation procedure and comparing it with the hydrostatic calculation, the required time for the deck passage to submerge is found to be approximately 20 hours, measured from the moment the valve is opened. At that moment, approximately 137 t of external water has been loaded into the vessel.

Figure 4.2.1.8. Dependence of the loaded water mass on the time

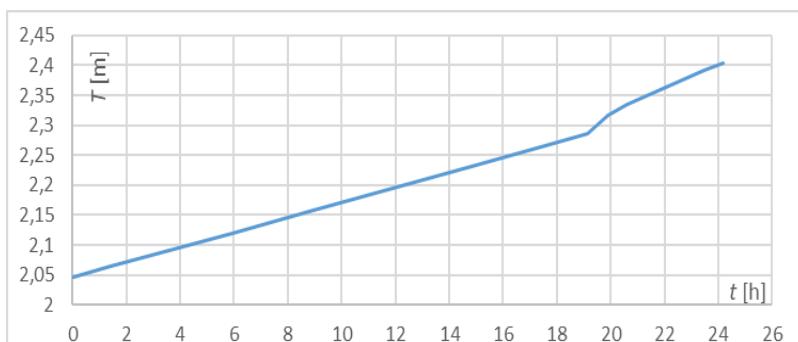
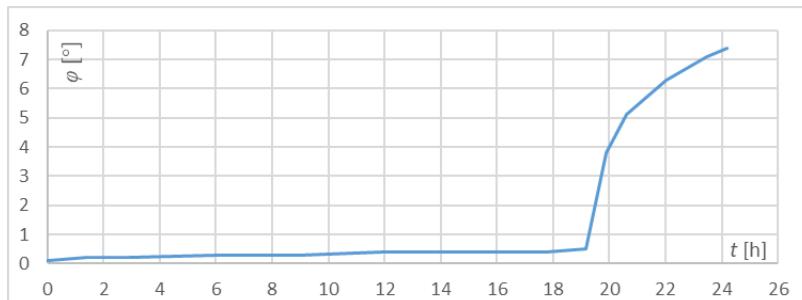
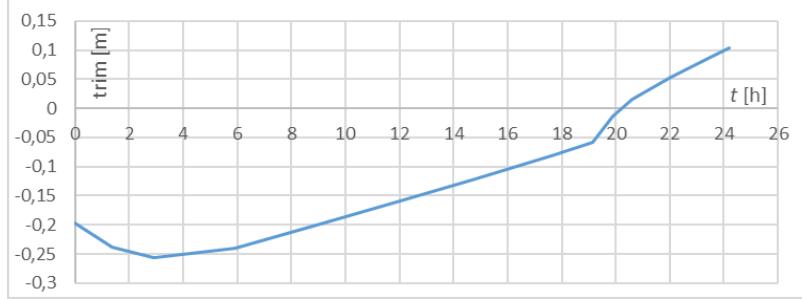
The changes in draft, heel angle, and trim over time are shown respectively in Figures 4.2.1.9, 4.2.1.10, and 4.2.1.11. The moment at which the crew noticed the flooding corresponds to the 20th hour from the start of calculation.

Figure 4.2.1.9. Change of the trim of the vessel as the function of time

Figure 4.2.1.10. Change of the heel of the vessel as the function of time

Figure 4.2.1.11. Change of the trim of the vessel as the function of time

It is interesting that at this very moment a sudden change in the floating condition occurs—there is an accelerated change in draft and trim, and the change in the heel angle is particularly pronounced. From the diagrams, the following values of the floating condition at the moment when the crew noticed the flooding can be read: mean draft of the vessel, $T = 2.317$ m; trim, $t = -0.014$ m (stern trim); heel, $\varphi = 4.1^\circ$ (heel to port side).

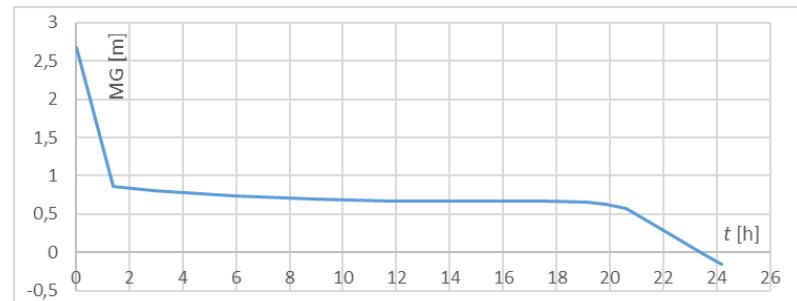
The reason for this sudden change is that the deck becomes submerged at that moment, which results in a reduction of the metacentric height and a deterioration of the vessel's stability. The change of the initial metacentric height as a function of time is shown in Figure 4.2.1.12.

Figure 4.2.1.12. Change of the initial metacentric height as a function of time

Based on the input assumptions, at the moment the valve was opened the initial metacentric height was approximately $MG = 2.7$ m. During the first hour of flooding, the water wets the bottom of the flooded compartments and a free-surface effect is created, which has a noticeable influence on the initial metacentric height. Subsequently, over a longer period of time, there are no significant changes with regard to stability. However, at the moment the deck becomes submerged, the initial metacentric height decreases, and from that point onward the stability changes drastically. Had the crew delayed their response and not taken measures to save the vessel, a complete loss of stability would have occurred due to negative metacentric height and flooding of the cargo hold bilge slightly more than 24 hours after the moment the valve was opened.

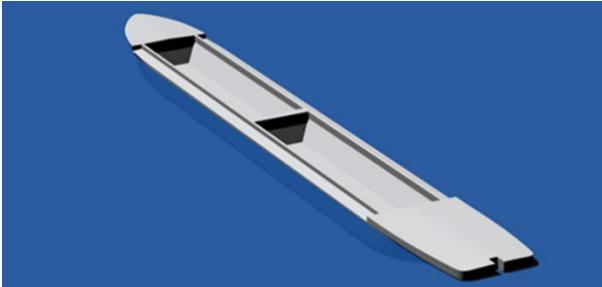
Figure 4.2.1.13. Flooding illustration: $t = 0 \text{ h } 0 \text{ min}$; $m = 0 \text{ t}$ (start of the flooding)

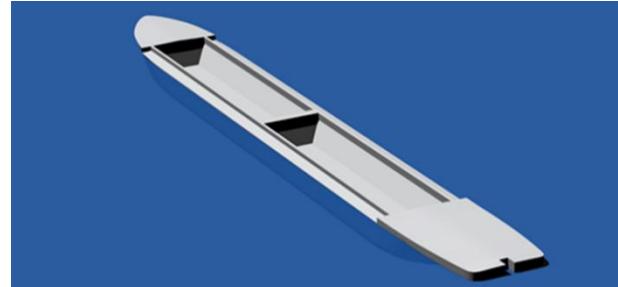
Figure 4.2.1.14. Flooding illustration: $t = 11 \text{ h } 50 \text{ min}$; $m = 80 \text{ t}$ (21.00, the crew did not notice the problem)

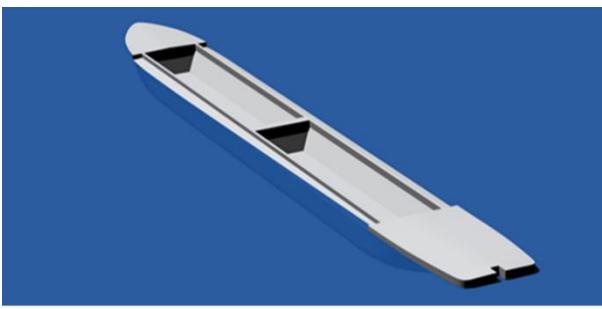
Figure 4.2.1.15. Flooding illustration:
 $t = 19 \text{ h } 10 \text{ min}$; $m = 130 \text{ t}$
(the deck begins to submerge)

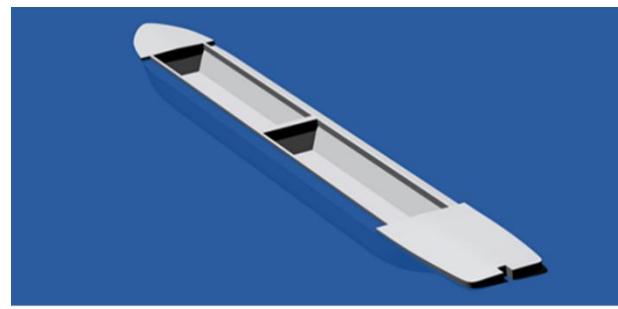
Figure 4.2.1.16. Flooding illustration:
 $t = 20 \text{ h } 10 \text{ min}$; $m = 137 \text{ t}$
(the crew notices the problem)

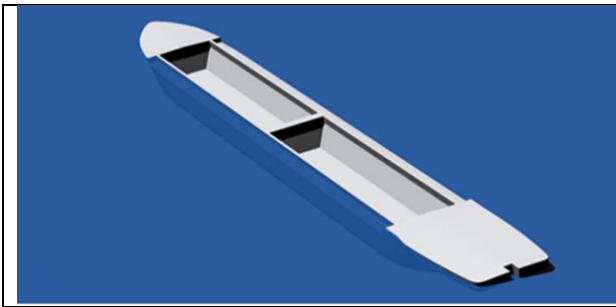
Figure 4.2.1.17. Flooding illustration:
 $t = 22 \text{ h } 0 \text{ min}$; $m = 150 \text{ t}$
submerged-progressive flooding would have followed)

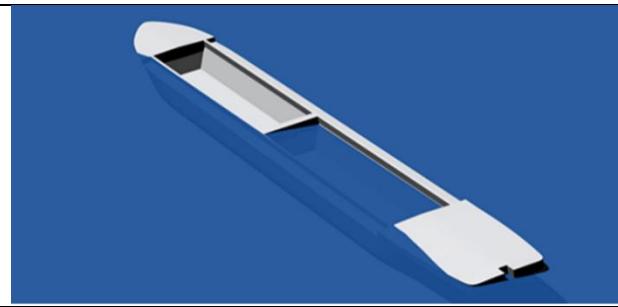
Figure 4.2.1.18. Flooding illustration:
 $t = 24 \text{ h } 10 \text{ min}$; $m = 165 \text{ t}$ (the bilge would have
reached the condition in the case the crew did not react)
