REPUBLIC OF SERBIA, CENTER FOR INVESTIGATION OF ACCIDENTS IN
TRANSPORT, SECTOR FOR INVESTIGATION OF ACCIDENTS IN
WATERBORNE TRAFFIC
Nemanjina 11, Belgrade

No.: 342-00-5/2024-03-4

Date: 27.12.2024.

ANNUAL REPORT FOR 2023

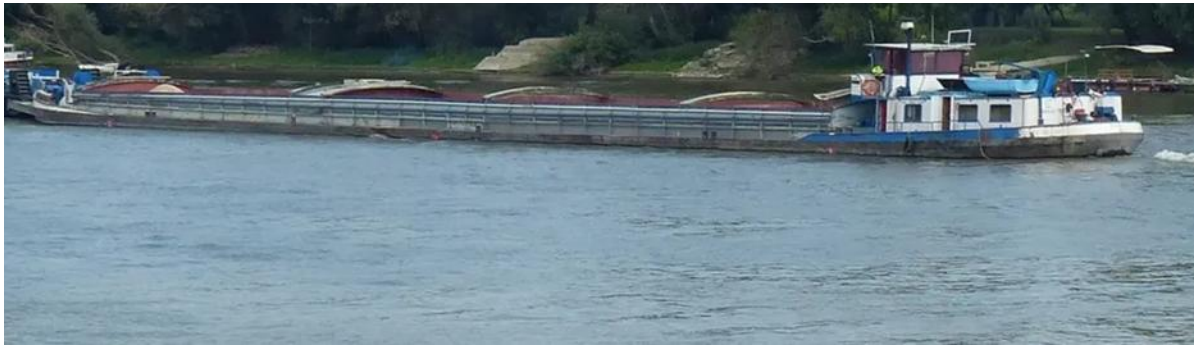
Figure 3.2.1. Motor cargo vessel “BEO“

On April 6, 2023, at approximately 12:30, at river kilometer 1051 + 300 m of the Danube River, an inland navigation incident occurred, involving water ingress into the cargo barge with registration No. "71771", which was part of the upstream composition of the motor cargo vessel "BEO". Following a maneuver to ground the barge on the right bank in an attempt to prevent sinking, the operational maneuver did not yield a positive result, and the barge ultimately sank on April 8, 2023, at approximately 5:30.

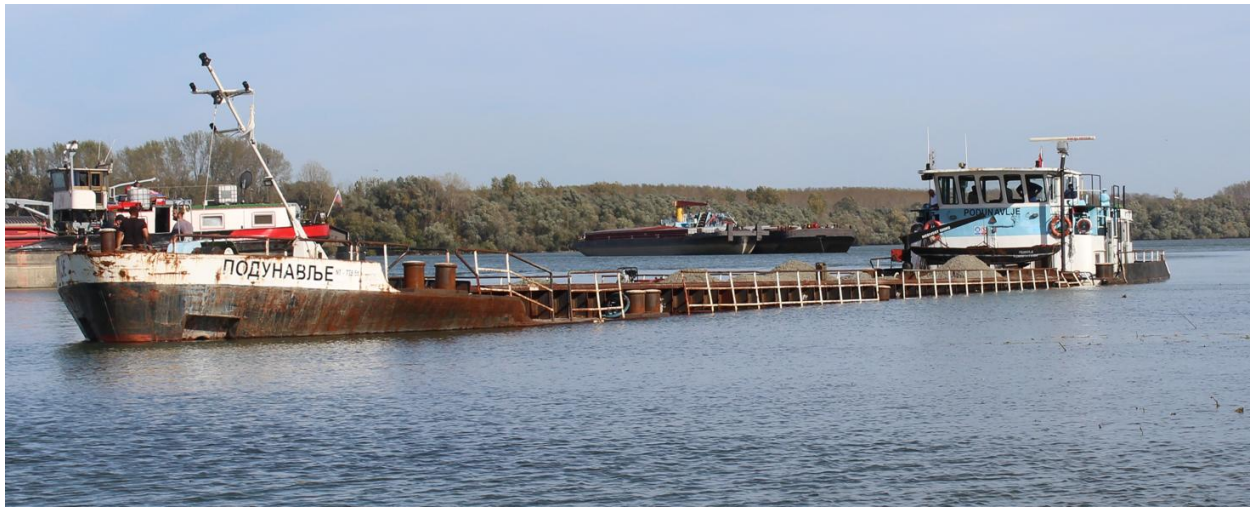
Figure 3.3.1. Motor cargo vessel “PODUNAVLJE“ at 1106 km + 200 m of the Danube River

On October 30, 2023, at approximately 05:00, at river kilometer 1106 + 200 m along the right bank of the Danube River, a navigation incident occurred involving the partial sinking of the anchored motor cargo vessel "PODUNAVLJE" (see Figure 3.3.1). The vessel flies the flag of the Republic of Serbia and is registered in the Ship Register of the Smederevo Port Authority.

The motor cargo vessel "PODUNAVLJE" was navigating upstream, loaded with 738 tons of natural gravel (according to the accompanying cargo document – bill of lading). The loading was carried out on October 29, 2023, at km 1065 of the Danube River under the dredger "BUKOVAC".
